### HISTORIC RESOURCES INVENTORY

1. Common name: \_\_\_\_\_
2. Historic name: \_\_\_\_\_
3. Street or rural address: 443 - 1st Street  
City Healdsburg Zip 95448 County Sonoma
4. Parcel number: 002-142-10
5. Present Owner: Johnson, Thomas & Beverly M Address: 2980 Mill Creek Rd.  
City Healdsburg Zip 95448 Ownership is: Public \_\_\_\_\_ Private X
6. Present Use: Residential Original use: Residential

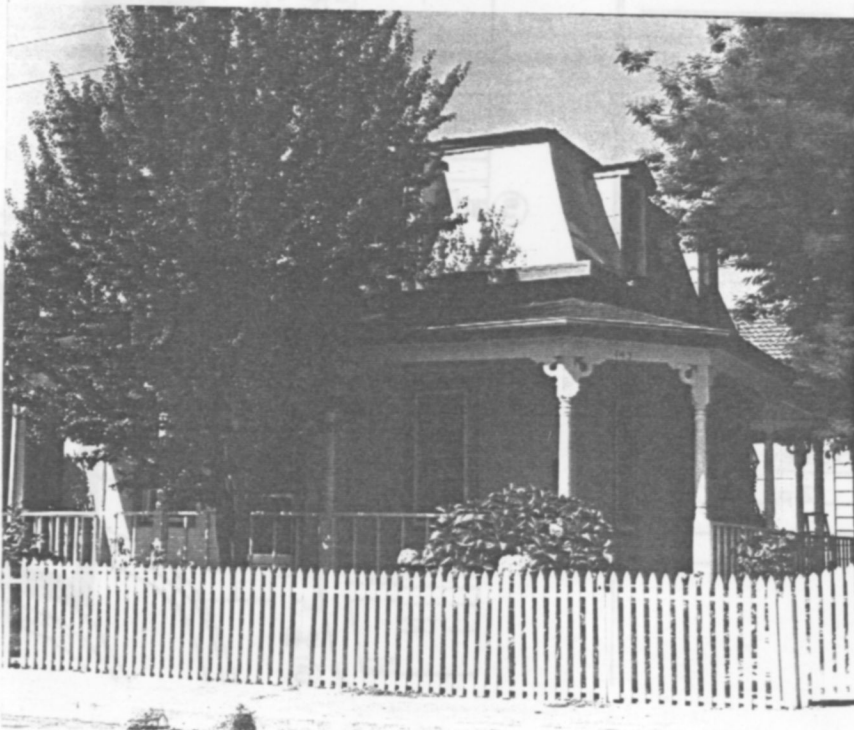
This two-story house has a mansard second story with double hung gabled mansard windows. The mansard roof is a low pitched hip roof with a simple cap at the cornice line. The cornice above the first floor is boxed and there is a verandah wrapping three sides with the back side partially enclosed. Turned columns with brackets support the verandah roof and a simple squared balustrade is an obvious later renovation. All the original siding has been covered with asbestos shingles and the original doors have been changed.

13. Condition: Excellent \_\_\_ Good X Fair \_\_\_ Deteriorated \_\_\_ No longer in existence \_\_\_
14. Alterations: Asbestos siding
15. Surroundings: (Check more than one if necessary) Open land \_\_\_ Scattered buildings \_\_\_ Densely built-up \_\_\_  
Residential X Industrial \_\_\_ Commercial \_\_\_ Other: \_\_\_
16. Threats to site: None known X Private development \_\_\_ Zoning \_\_\_ Vandalism \_\_\_  
Public Works project \_\_\_ Other: \_\_\_
17. Is the structure: On its original site? \_\_\_ Moved? \_\_\_ Unknown? \_\_\_
18. Related features: \_\_\_

Although the second floor appears to be a later addition, this is the only true mansard roof structure in Healdsburg.
