HISTORIC RESOURCES INVENTORY

1. Common name: _____
2. Historic name: _____
3. Street or rural address: 226 Center Street
City Healdsburg, CA Zip 95448 County Sonoma
4. Parcel number: 002-241-05-7
5. Present Owner: Modini, Margaret T. & J.L. Jr Address: P.O. Box 272
City Healdsburg, CA Zip 95448 Ownership is: Public _____ Private X
6. Present Use: Residential Original use: _____

- 7a. Architectural style: Queen Anne cottage
- 7b. Briefly describe the present *physical description* of the site or structure and describe any major alterations from its original condition:

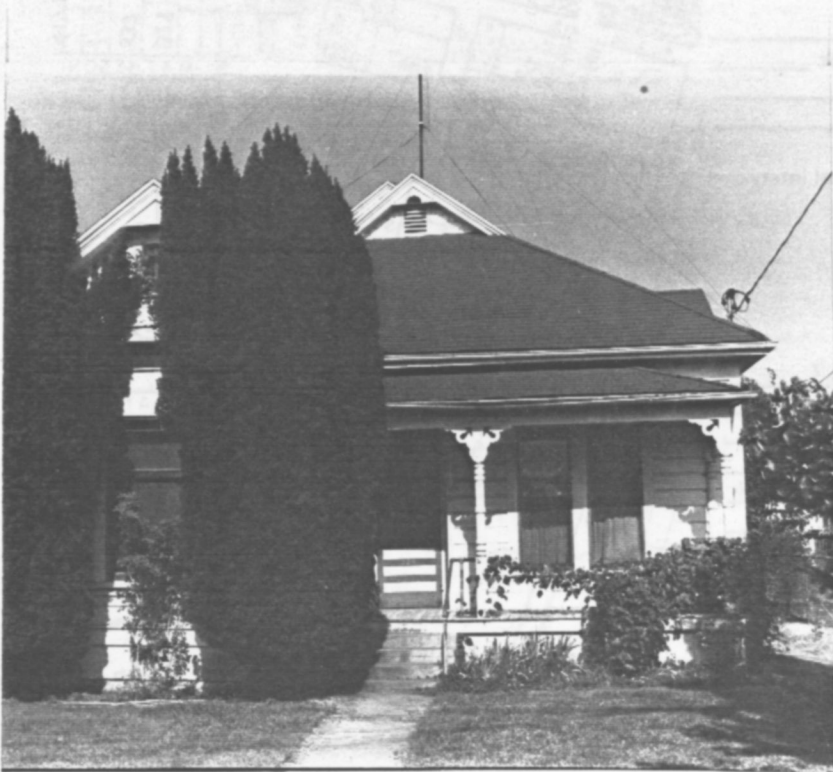
This one story home has a double-gablet hip roof and a gabled front bay. The front gablet has a ventilator as do side gables while the gable of the rectangular bay has a small window with colored glass panes. All the gables are filled with cut shingles and the ones in front have sunburst gable braces. The house has a boxed cornice and channel rustic siding. The windows are double-hung with plain frames. The upper pane of the bay window has colored panes and the recessed front door has a transom over it. The front and side porches have hip roofs with turned posts and sawn brackets.

13. Condition: Excellent ___ Good X Fair ___ Deteriorated ___ No longer in existence ___
14. Alterations: _____
15. Surroundings: (Check more than one if necessary) Open land ___ Scattered buildings ___ Densely built-up ___
Residential X Industrial ___ Commercial X Other: _____
16. Threats to site: None known X Private development ___ Zoning ___ Vandalism ___
Public Works project ___ Other: _____
17. Is the structure: On its original site? X Moved? ___ Unknown? ___
18. Related features: _____
