HISTORIC RESOURCES INVENTORY

1. Common name: \_\_\_\_\_
2. Historic name: William Cummings House
3. Street or rural address: 17 Fitch Street  
City Healdsburg Zip 95448 County Sonoma
4. Parcel number: 002-261-09-7
5. Present Owner: Fisher Ken Address: 17 Fitch Street  
City Healdsburg Zip 95448 Ownership is: Public \_\_\_\_\_ Private X
6. Present Use: Residential Original use: Residential

- 7a. Architectural style: Gabled Cottage
- 7b. Briefly describe the present *physical description* of the site or structure and describe any major alterations from its original condition:

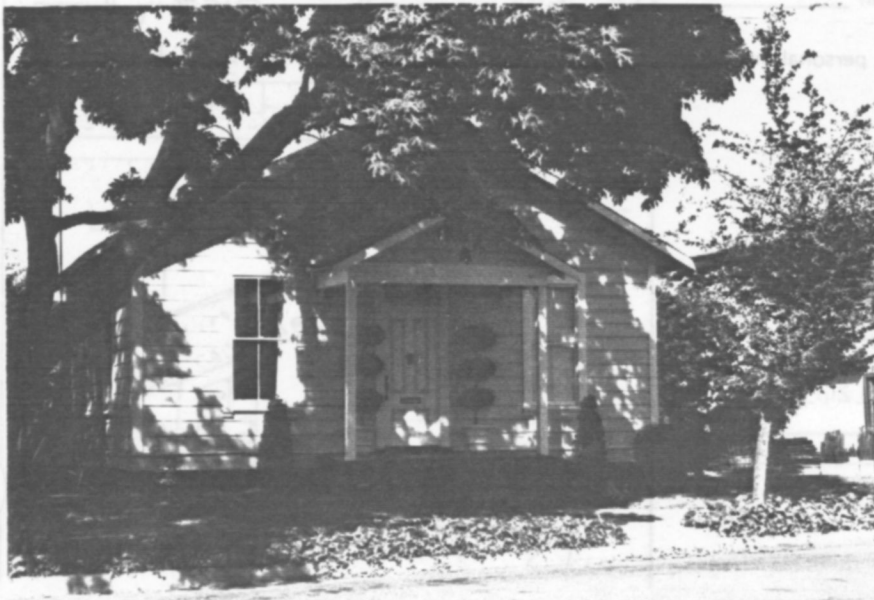
This 1 story gabled cottage has open eaves w/the rafter ends covered by a plain fascia board. The open gable has the same channel rustic siding as the rest of the house. A belt course sparate the house & foundation levels. Windows are single double-hungs w/2 panes in each sash. Frames are plain but there are molded sill blocks. Above the paneled front door is a single panes transom. The gabled front portico has exposed rafter ends, plain square posts & sawn brackets.
