HISTORIC RESOURCES INVENTORY

1. Common name: Cuneo Barn
2. Historic name: Cuneo Barn
3. Street or rural address: 425 Grant Avenue
City Healdsburg, CA Zip 95448 County Sonoma
4. Parcel number: 086-020-02
5. Present Owner: Cuneo, Edna Address: 425 Grant Avenue
City Healdsburg, CA Zip 95448 Ownership is: Public _____ Private X
6. Present Use: Private Non-comm. Original use: Private Non-comm.

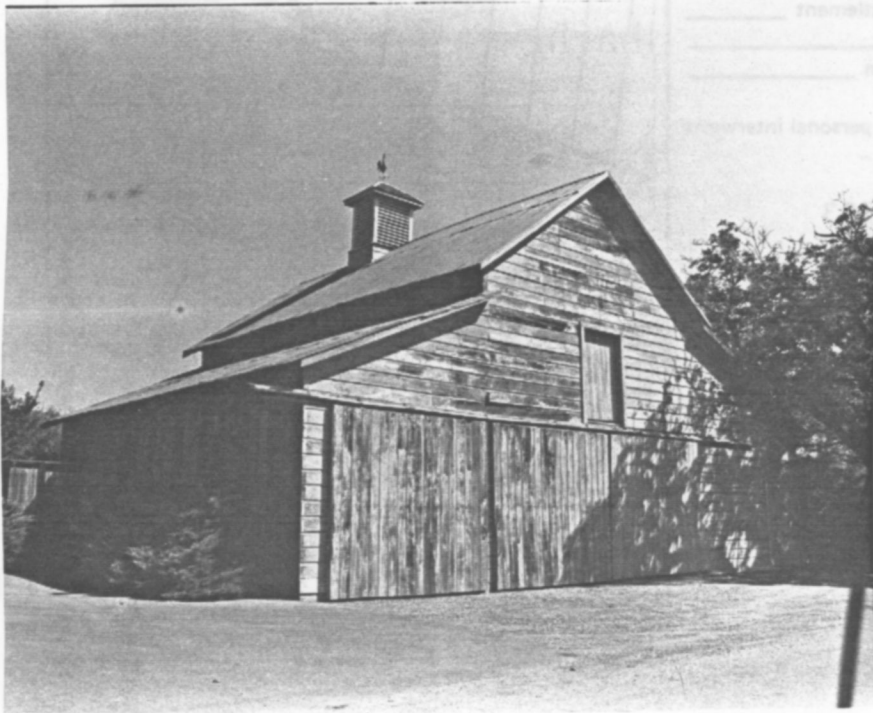
This barn has a two story center section with a gable roof and side wings with shed roofs. The shed roofs have slightly different pitches. The cornice is closed and the structure has horizontal channel rustic siding in front and vertical rustic on the sides. The right half of the facade appears to have been altered as the siding is slightly narrower than that on the left. There are three large doors on an overhead track which extends past the left side of the structure. To the right is a conventional door and centered elbow. The gable is a hayloft door. Topping the barn is a vented cupola with a rooster weathervane.

13. Condition: Excellent ___ Good ___ Fair X Deteriorated ___ No longer in existence ___
14. Alterations: Corrugated metal roof; rooster weathervane
15. Surroundings: (Check more than one if necessary) Open land X Scattered buildings ___ Densely built-up ___
Residential X Industrial ___ Commercial ___ Other: _____
16. Threats to site: None known ___ Private development X Zoning ___ Vandalism ___
Public Works project ___ Other: _____
17. Is the structure: On its original site? X Moved? ___ Unknown? ___
18. Related features: _____
