HISTORIC RESOURCES INVENTORY

1. Common name: _____
2. Historic name: _____
3. Street or rural address: 14645 Grove Street
City Healdsburg, CA Zip 95448 County Sonoma
4. Parcel number: 089-130-08-2
5. Present Owner: Maida, Stanley J. Address: 14645 Grove Street
City Healdsburg, CA Zip 95448 Ownership is: Public _____ Private X
6. Present Use: Residential Original use: Residential

- 7a. Architectural style: Queen Anne Transitional
- 7b. Briefly describe the present *physical description* of the site or structure and describe any major alterations from its original condition:

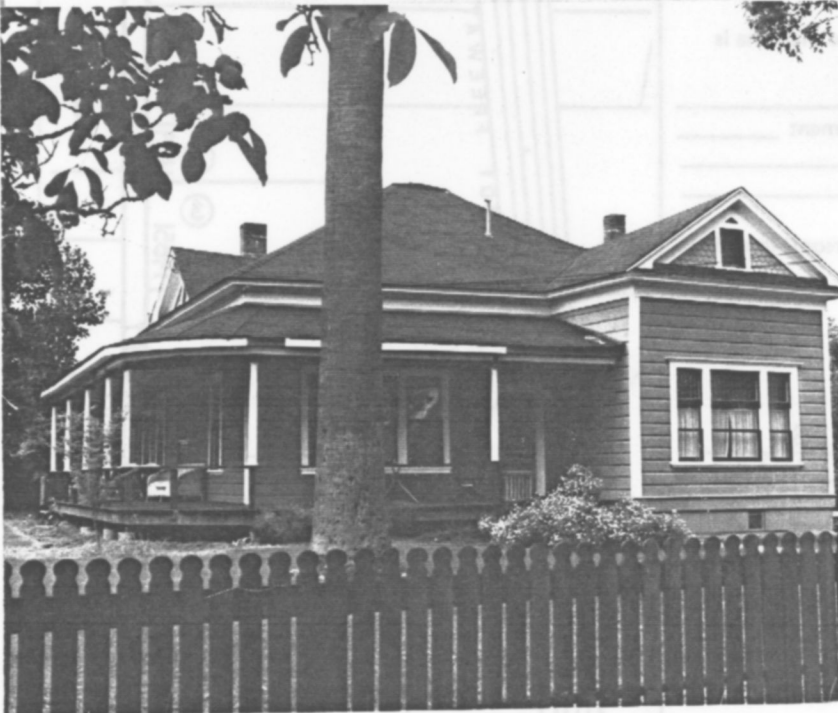
This basically square one-story house has a truncated hip roof with a side gable, a gabled dormer on the opposite side, and a gabled, square, front bay. There is a porch on two sides which is curved at the corner. In the rear is a hip roofed addition. The cornice is boxed and the gables have small windows and cut shingles. The windows are double-hung with some of the upper sashes in a diamond pattern. The porch has slender round columns that once sat atop a solid balustrade, currently under repair. The siding is channel rustic

13. Condition: Excellent ___ Good X Fair ___ Deteriorated ___ No longer in existence ___
14. Alterations: Work in process
15. Surroundings: (Check more than one if necessary) Open land ___ Scattered buildings ___ Densely built-up ___
Residential X Industrial ___ Commercial ___ Other: ___
16. Threats to site: None known X Private development ___ Zoning ___ Vandalism ___
Public Works project ___ Other: ___
17. Is the structure: On its original site? X Moved? ___ Unknown? ___
18. Related features: Two very tall palm trees
