HISTORIC RESOURCES INVENTORY

1.	Common nam	ne:							- 12 INDITIONAL PROPERTY.	
2.	Historic name		IsbnsV	Zoning		devolopment	Z_Private	None known	Threath to site:	16.
3.	Street or rura	address:	401	Haydon		book 2	Carlo to	Co te etigin		
	City	Healdsbu	irg	20	_Zip_	95448	Count	y Sonom	a	101

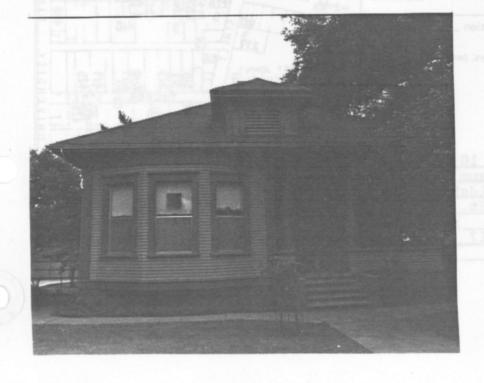
This square hip roofed bungalow sports a front dormer w/ towered vent and hip roof. There is a boxed cornice above a plain freeze. To the left of the front gable is a 3 windowed slanted bay. A recessed veranda is found on the front left corner. The windows are double hung & occur in groups of 3 in some places. The house siding is narrow lap rustic, vertical boards covering the foundation. The foundation & house levels are defined by a plain belt course. Interesting details are flutted pilasters on the front corners, molded caps above the windows, and columns w/ Ionic capitals on the veranda balustrade.

13.	Condition: Excellent X Good Fair Deteriorat	ed No longer in existence
14.	Alterations:Some aluminum windows	HISTORIC RESOURCES INVENTORY
15.	Surroundings: (Check more than one if necessary) Open land Residential X Industrial Commercial Other:	Scattered buildings Densely built-up
