State of California — The Resources Agency DEPARTMENT OF PARKS AND RECREATION

HISTORIC RESOURCES INVENTORY

-					
DE	NTIF	Common name:	Belle de Jour Bed	and	Breakf	ast	11 2000	or regulariyunus	201
	2.	Historic name:	Leo Jehle House	custs	0islor	lah lah	mubnl_	Regidential	
	3.	Street or rural ad	dress: 16276 Healdsb	urg	Avenue	known X_Priva	mol/i	Threats to site	.81
		City Heald	dsburg, CA	_ Zip	95448	County	Son	noma	
	4.	Parcel number:	091-040-45	0270	atinavi	s beall es	47		
	5.	Present Owner:	Piper, Custis			Address:1	6276	Healdsbur	g Ave
		City Healds	sburg, CA Zip	954	48_Ownersh	hip is: Public	a lestro	PrivateX	.01
	6.	Present Use: Co	ommercial/Resident	ial	Original use:	Resident	ial	bus edens

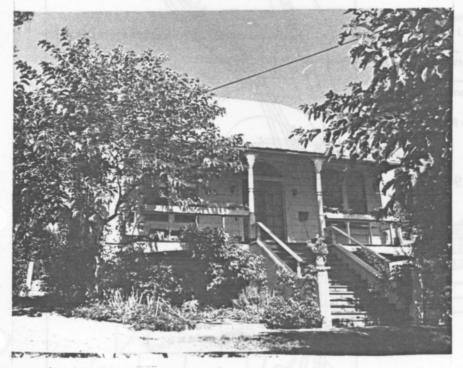
This one-story house has a truncated hip-roof and channel rustic siding. The cornice is boxed and is bracketed. The windows are double-hung with semi-elliptical tops. They are in pairs on either side of the centered front door and have molded sills and bracketed hoods. The french style front doors are topped by a semi-elliptical transom and similarily framed. The raised front porch has turned posts and sawn brackets. The stair railings are supported by two small, turned balusters. The area beneath the porch is open to allow light into windows set in the foundation.
