HISTORIC RESOURCES INVENTORY

1. Common name: _____
2. Historic name: Cerri and Maggenti Grocery
3. Street or rural address: 417 & 419 Healdsburg Ave.
City Healdsburg, Calif. Zip 95448 County Sonoma
4. Parcel number: 002-172-02-1
5. Present Owner: Byrd, Benjamin B. & Cynthia A. Address: 25 W. Grant St
City Healdsburg, CA Zip 95448 Ownership is: Public Private
6. Present Use: Commercial Original use: Commercial

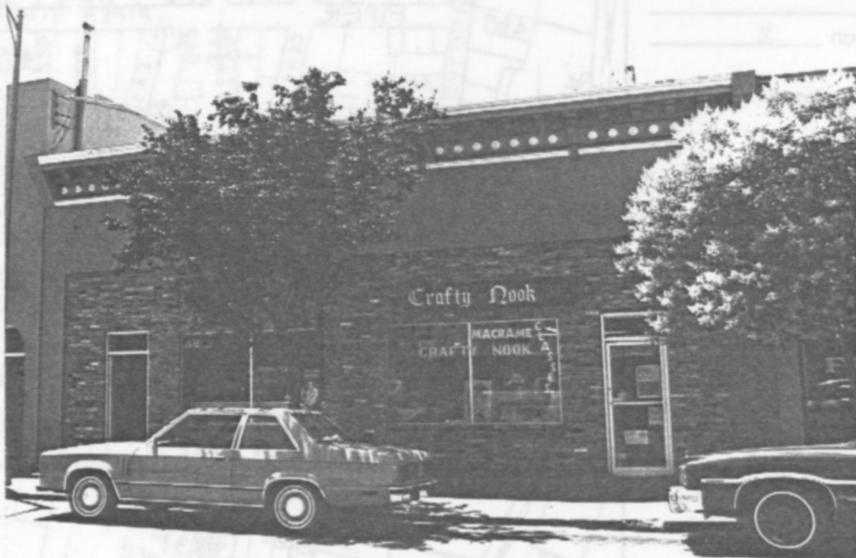
This extremely altered late victorian building has a terra cotta cornice with large and small brackets nosings and small buttons filling in the frieze. Below the frieze is about a 4' band of stucco with the balance of the structure, down to the sidewalk, being covered in used brick. There are two aluminum entry doors and two large fixed windows in the front facade.

13. Condition: Excellent ___ Good Fair ___ Deteriorated ___ No longer in existence ___
14. Alterations: 1st floor front facade
15. Surroundings: (Check more than one if necessary) Open land ___ Scattered buildings ___ Densely built-up ___
Residential ___ Industrial ___ Commercial Other: ___
16. Threats to site: None known Private development ___ Zoning ___ Vandalism ___
Public Works project ___ Other: ___
17. Is the structure: On its original site? Moved? ___ Unknown? ___
18. Related features: ___
