HISTORIC RESOURCES INVENTORY

1. Common name: \_\_\_\_\_
2. Historic name: \_\_\_\_\_
3. Street or rural address: 1560 South Fitch Mountain Road  
City Healdsburg, CA Zip 95448 County Sonoma
4. Parcel number: 087-213-02
5. Present Owner: John H. Nolan Address: \_\_\_\_\_  
City Healdsburg, CA Zip 95448 Ownership is: Public \_\_\_\_\_ Private X
6. Present Use: Residential Original use: Residential

- 7a. Architectural style: Vernacular Cabin
- 7b. Briefly describe the present *physical description* of the site or structure and describe any major alterations from its original condition:

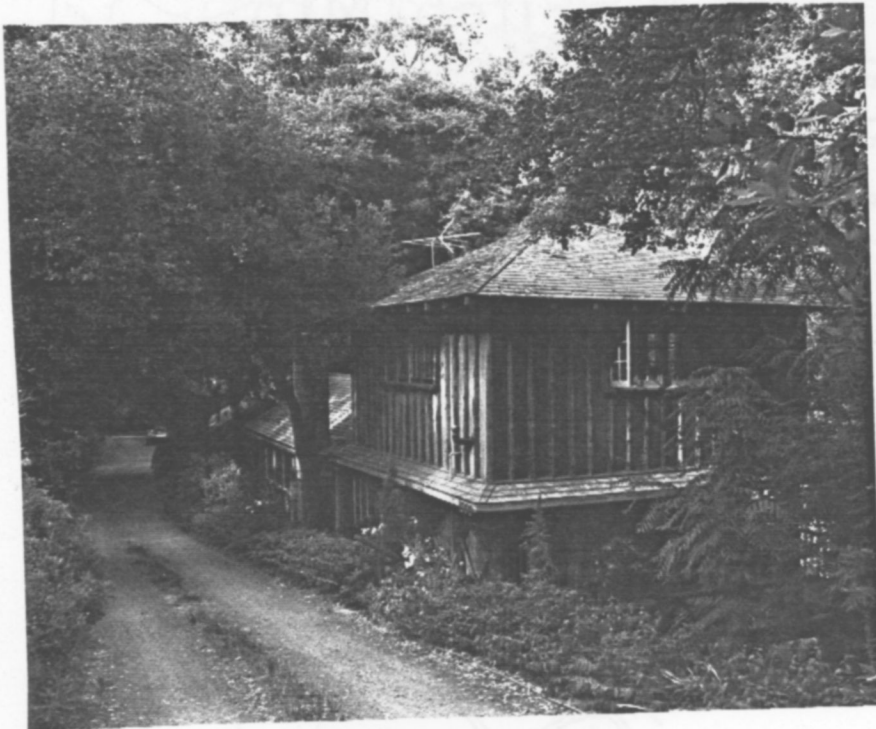
This structure has a two-story section with a hip-roof with a one-story section to one side. The rafter ends are exposed and the two-stories are delineated by very narrow, shingled, overhang. Casement windows with six panes are found in groups around the structure. The siding is board and batten with the battens being small redwood trunks. A post and rail balustrade runs the entire length of the structure above the raised foundation.

13. Condition: Excellent \_\_\_ Good \_\_\_ Fair X Deteriorated \_\_\_ No longer in existence \_\_\_
14. Alterations: \_\_\_\_\_
15. Surroundings: (Check more than one if necessary) Open land X Scattered buildings X Densely built-up \_\_\_  
Residential \_\_\_ Industrial \_\_\_ Commercial \_\_\_ Other: \_\_\_\_\_
16. Threats to site: None known X Private development \_\_\_ Zoning \_\_\_ Vandalism \_\_\_  
Public Works project \_\_\_ Other: \_\_\_\_\_
17. Is the structure: On its original site? X Moved? \_\_\_ Unknown? \_\_\_
18. Related features: \_\_\_\_\_
