HISTORIC RESOURCES INVENTORY

1. Common name: _____
2. Historic name: Susie N. Field House
3. Street or rural address: 11424 Eastside Road
City Healdsburg, CA Zip 95448 County Sonoma
4. Parcel number: 066-320-25
5. Present Owner: Tomasello, Elia Address 11424 Eastside Road
City Healdsburg, CA Zip 95448 Ownership is: Public _____ Private X
6. Present Use: Residential Original use: Residential

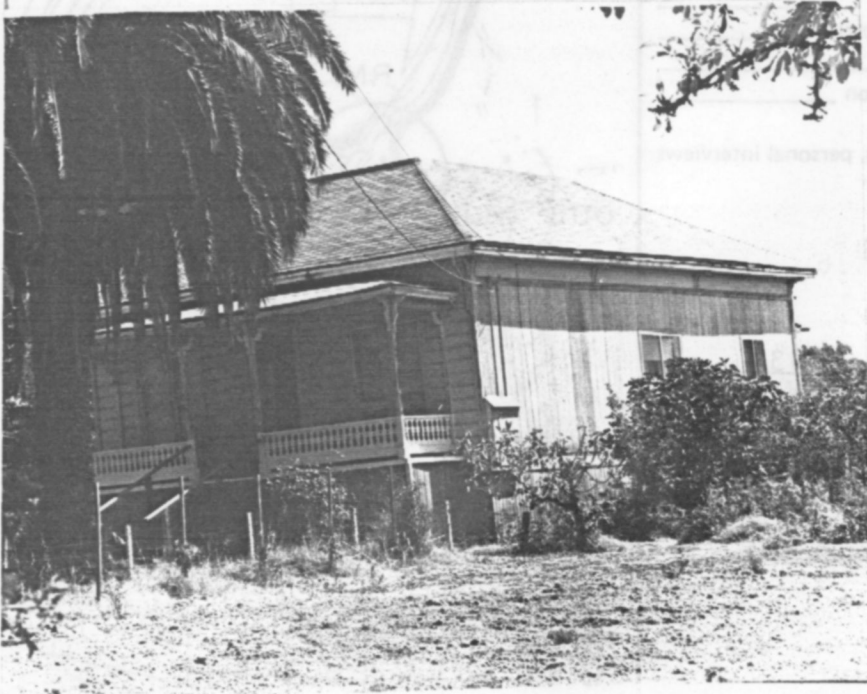
A truncated hip roof tops this square, one-story house. The cornice is boxed and has pairs of sawn brackets. The front of the house retains its original channel rustic siding and paired, bouble-hung windows with molded caps. The recessed entrance has molded panels on either side of the door and transom. Vertical siding and sliding aluminum windows have replaced the original materials on other parts of the structure. The front porch has a hip roof with slightly shap-ed posts, sawn brackets with a sawn balustrade. The stairs and railing do not appear original.

13. Condition: Excellent ___ Good ___ Fair X Deteriorated ___ No longer in existence ___
14. Alterations: Additions, renovation
15. Surroundings: (Check more than one if necessary) Open land X Scattered buildings ___ Densely built-up ___
Residential ___ Industrial ___ Commercial ___ Other: ___
16. Threats to site: None known X Private development ___ Zoning ___ Vandalism ___
Public Works project ___ Other: ___
17. Is the structure: On its original site? X Moved? ___ Unknown? ___
18. Related features: Palm trees under tower

Viewed head-on, this house presents a pleasingly symmetrical facade and exhibits some of the period's typical decorative elements such as the sawn brackets and balustrade and paneled entry.
