State of Calif	ornia - The	Resources Agency
DEPARTMENT	OF PARKS	AND RECREATION

HISTORIC RESOURCES INVENTORY

Common name:	ines trem	Private develop	X mercent an			er ar
2.	Historic name: Foreman House			NTO TO THE	106[010	Litow and	19
3.	Street or rural address: 315 Fit	ch Street					
	City_ Healdsburg		95448	County	Sono	ma	11 11
	Parcel number: 002-191-12						
	Present Owner: Retana, Antoni	Lo R & Patr	ricia J.	Address:	315	Fitch	Street
	City_Healdsburg	Zip 95448	3_Ownership	is: Public	lonaș anul	Private	Х
	Present Use: _ Residential		riginal use:

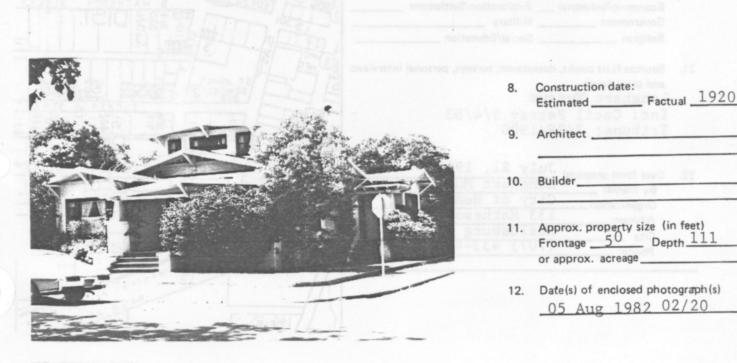
This two-story multi-gabled bungalow on the corner of Fitch and Plaza is a large example of the 1920's bungalows that appear on Plaza Street and throughout Healdsburg.

The many gables are low and wide with exposed rafters and knee-brace brackets. Windows are single or grouped in three with a wide fixed central pane and narrow double-hung pane flanking. The entrance porch has heavy square stucco posts topped with short tapered wood pillars.

This is a particularly good example of Craftsman style with unusual effort put into having the structural elements such as the roof truss for the front porch be exposed and therefore form the decorative element as well.
