### HISTORIC RESOURCES INVENTORY

1. Common name: \_\_\_\_\_
2. Historic name: Hamilton House
3. Street or rural address: 321 Fitch Street  
City Healdsburg, Ca Zip 95448 County Sonoma
4. Parcel number: 002-192-10-2
5. Present Owner: Cook Edith Valet Life Estate Address: 321 Fitch Street  
City Healdsburg Ca Zip 95448 Ownership is: Public \_\_\_\_\_ Private XX
6. Present Use: residential Original use: residential

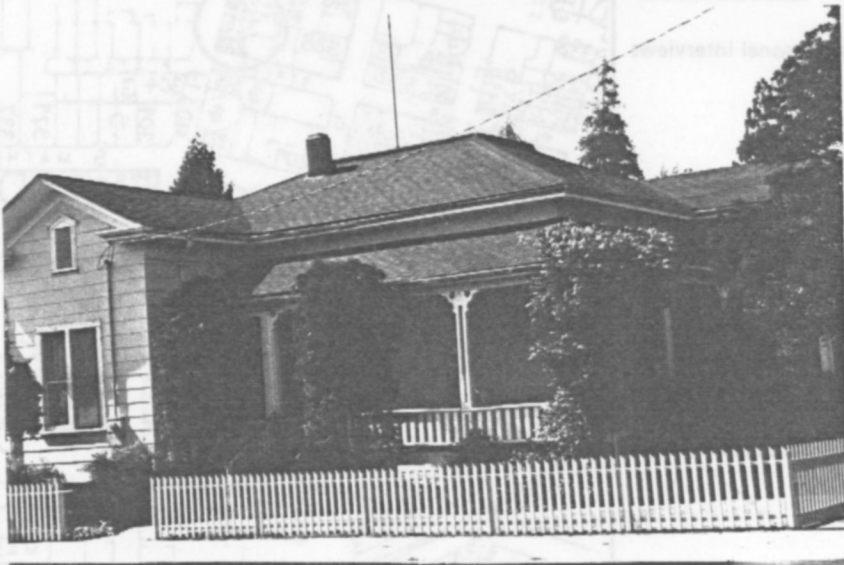
This larger cottage has a truncated hip roof with open gables over front and side bays. Much of the original millwork appears to have been removed when the asbestos shingles covering the siding were applied. The cornice is boxed with returns on the gable face. The open gable has a gable vent and asbestos shingles covering the original filling. The hip roof verandah extends across the front and side. Paired square post with suron brackets support the verandah roof and the balustrade system has been altered.

13. Condition: Excellent \_\_\_ Good X Fair \_\_\_ Deteriorated \_\_\_ No longer in existence \_\_\_
14. Alterations: \_\_\_\_\_
15. Surroundings: (Check more than one if necessary) Open land \_\_\_ Scattered buildings \_\_\_ Densely built-up \_\_\_  
Residential X Industrial \_\_\_ Commercial \_\_\_ Other: \_\_\_\_\_
16. Threats to site: None known X Private development \_\_\_ Zoning \_\_\_ Vandalism \_\_\_  
Public Works project \_\_\_ Other: \_\_\_\_\_
17. Is the structure: On its original site? X Moved? \_\_\_ Unknown? \_\_\_
18. Related features: \_\_\_\_\_

19. Briefly state historical and/or architectural importance (include dates, events, and persons associated with the site.)  
In spite of the removal of some detailing and covering the siding with asbestos shingles, this structure still maintains a strong period character and with restoration would be one of the more outstanding structures in the neighborhood.  
Built by a widow, Louisa Hamilton, of the pioneer farming family of Geyserville in 1890, this residence lies within the region of the original 1857 town plat.
