### HISTORIC RESOURCES INVENTORY

1. Common name: \_\_\_\_\_
2. Historic name: \_\_\_\_\_
3. Street or rural address: 535 Fitch Street  
City Healdsburg Zip 95448 County Sonoma
4. Parcel number: 002-122-08
5. Present Owner: Hayes, Carole L Address: 535 Fitch Street  
City Healdsburg Zip 95448 Ownership is: Public \_\_\_\_\_ Private X
6. Present Use: Residential Original use: Residential

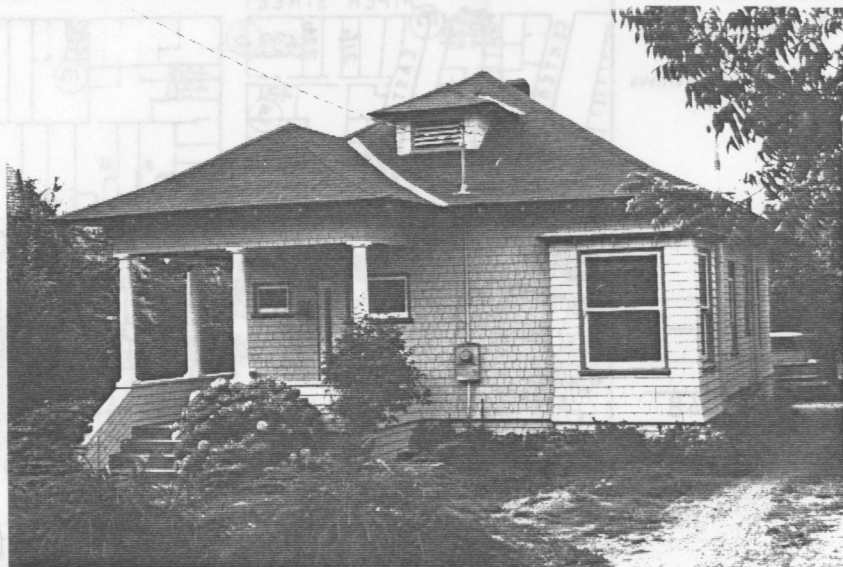
This small cottage has a hip roof with ventilating dormer in front and a small hip roofed "L" forming the porch roof. The rafter tails are exposed and decoratively sawn to add a slight upward flare to the eave line. The exterior walls are also flared at the water table. The entire exterior is shingled including the porch and stair balustrade system. Turned columns support the porch roof. There is a small cantilevered bay window on the corner of the building.

This is a prime example of transitional architecture in that it contains elements of both victorian (turned columns) and craftsman (open rafters and plain shingled exterior) styles.
