HISTORIC RESOURCES INVENTORY

1. Common name: Healdsburg Oil Company Office
2. Historic name: _____
3. Street or rural address: 423 Foss Street
City Healdsburg, CA. Zip 95448 County Sonoma
4. Parcel number: 002-173-19-3
5. Present Owner: Pimentel, Anthony M. & Daine M. Address: 3204 Fulton Road
City Fulton, CA Zip 95439 Ownership is: Public _____ Private
6. Present Use: Residential Original use: Residential

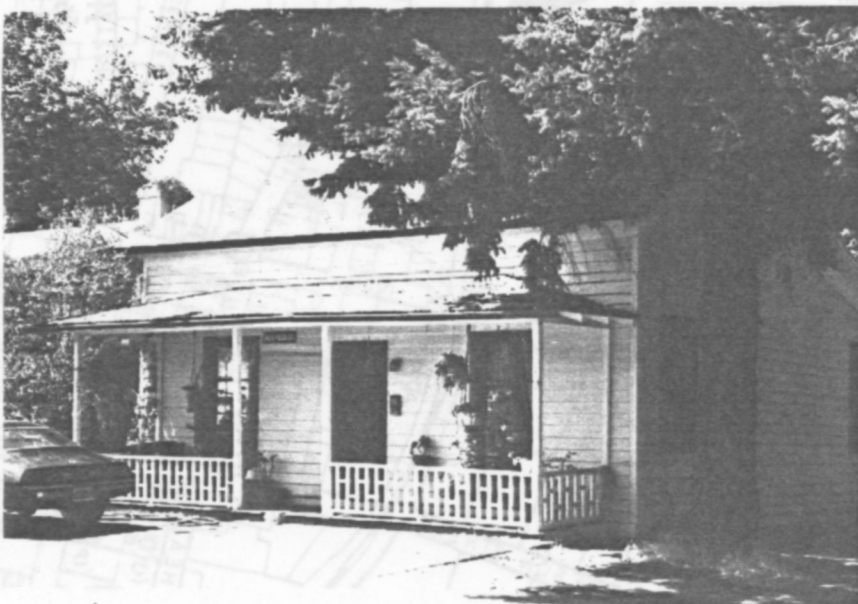
This small cottage has gables at each side with the roof sloping down lower on the rear side. There is a centralized entry door in the front flanked by two multi-paned windows. The small front verandah has an open framed hip roof supported by square chamfered posts with a geometric patterned balustrade. The siding is narrow lap type.

This is a nice example of the most modest type of residence in the area. This house shows a curious phenomena peculiar to some of the earlier cottages where true lap siding was used. The siding is cut to butt into the corner boards and frieze boards rather than go under them. Originally a residence along the 400 block of West Street (Healdsburg Avenue). built between 1867 and 1876, this structure was moved to its present location before 1911 and was used as the first office of the Healdsburg Oil Co. when it was started by Alvin Pitts in 1912 and sold to A.C. Golpin that same year. This was the site of the first Shell Oil Co. in Healdsburg.
