HISTORIC RESOURCES INVENTORY

1. Common name: _____
2. Historic name: Ottmer House
3. Street or rural address: 467 Healdsburg Avenue
City Healdsburg Zip 95448 County Sonoma
4. Parcel number: 002-113-06
5. Present Owner: Brown, Eva Address: 467 Healdsburg Ave.
City Healdsburg Zip 95448 Ownership is: Public _____ Private X
6. Present Use: Residential Original use: Residential

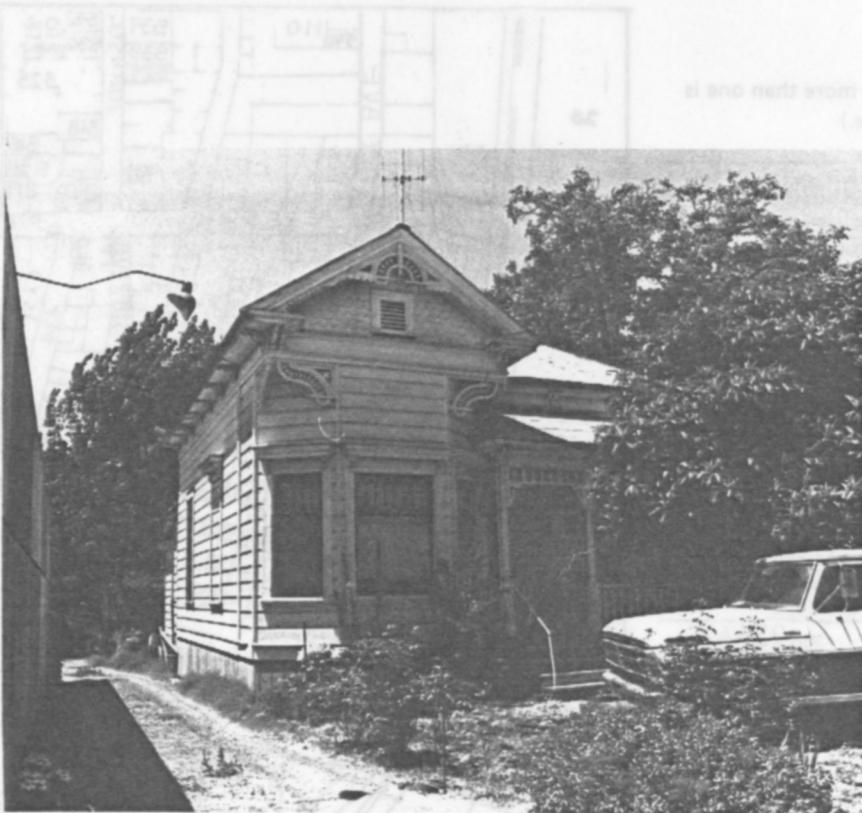
This small cottage with hip roof with gables is a queen anne style. The front "L" is angled and the gable over it has a gable vent, fishscale shingles; gable brace and angled brackets below. The double-hung windows have flat hoods over. The main cornice is boxed with brackets under. The front windows have ornamental sash and the porch has turned columns and fretwork with an ornamental balustrade system.

8. Construction date:
Estimated 1893 Factual _____
9. Architect _____
10. Builder _____
11. Approx. property size (in feet)
Frontage _____ Depth _____
or approx. acreage _____
12. Date(s) of enclosed photograph(s)
21 Sept 82 19/29
