HISTORIC RESOURCES INVENTORY

1. Common name: Roma Vista Winery
2. Historic name: Simi Winery/French-American Wine Company
3. Street or rural address: 420 Hudson Street
City Healdsburg, CA Zip 95448 County Sonoma
4. Parcel number: 002-322-03-0
5. Present Owner: Cuneo, Edna & Soracco, Robert J. Address: 425 Grant Avenue
& John R. Trustees
City Healdsburg, CA Zip 95448 Ownership is: Public _____ Private X
6. Present Use: Commercial Original use: Winery

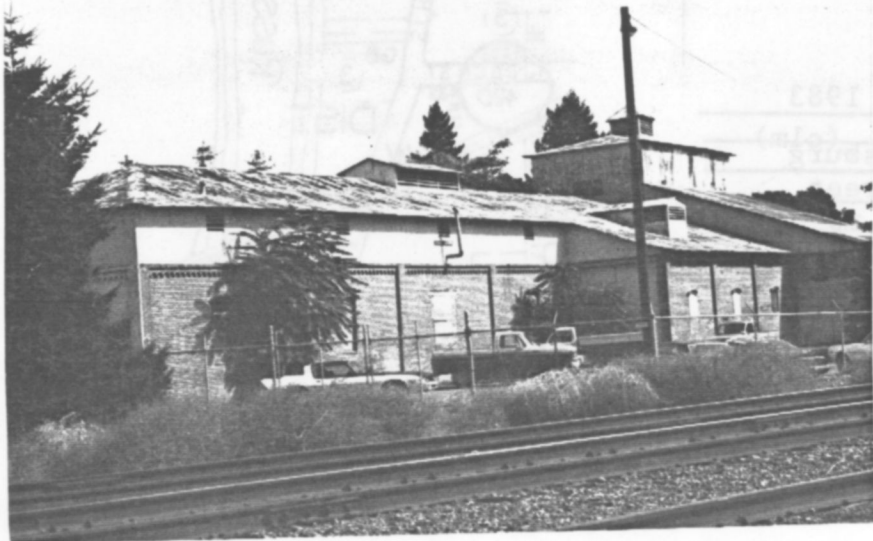
8. Construction date:
Estimated 1895 Factual _____
9. Architect _____
10. Builder _____
11. Approx. property size (in feet)
Frontage 281.5 Depth 470
or approx. acreage _____
12. Date(s) of enclosed photograph(s)
7 Oct 82 Bldg 1 24/19
from SW & 24/20 from E

Two buildings occupy this site. The first has a large lower portion of brick with regularly placed pilasters. The windows have segmental arch windows (now boarded over) that have arched brick hoods. At the top of the walls, the bricks are laid to form a corbel. Above the bricks is corrugated metal with vents and a hip and gable metal roof. Gabled ventilators extend above the roof. The other part of the first building is made of corrugated sheets of metal with two large shed roofed wings and a central tower like portion with a hip roof and ventilator. This building also has two small additions. The few openings are located up high and others appear to be covered over. The second building is rectangular with a gable roof and exposed rafter ends. A ventilator is located on the ridge. There is a large warehouse door and two small openings with grids over them. The entire structure is covered with corrugated metal.
