HISTORIC RESOURCES INVENTORY

1. Common name: _____
2. Historic name: _____
3. Street or rural address: 820 Johnson Street
City Healdsburg, CA Zip 95448 County Sonoma
4. Parcel number: 002-023-18-2
5. Present Owner: Bakker, Lola A. Address: 820 Johnson Street
City Healdsburg, CA Zip 95448 Ownership is: Public _____ Private X
6. Present Use: Residential Original use: Residential

- 7a. Architectural style: Craftsman Bungalow
- 7b. Briefly describe the present *physical description* of the site or structure and describe any major alterations from its original condition:

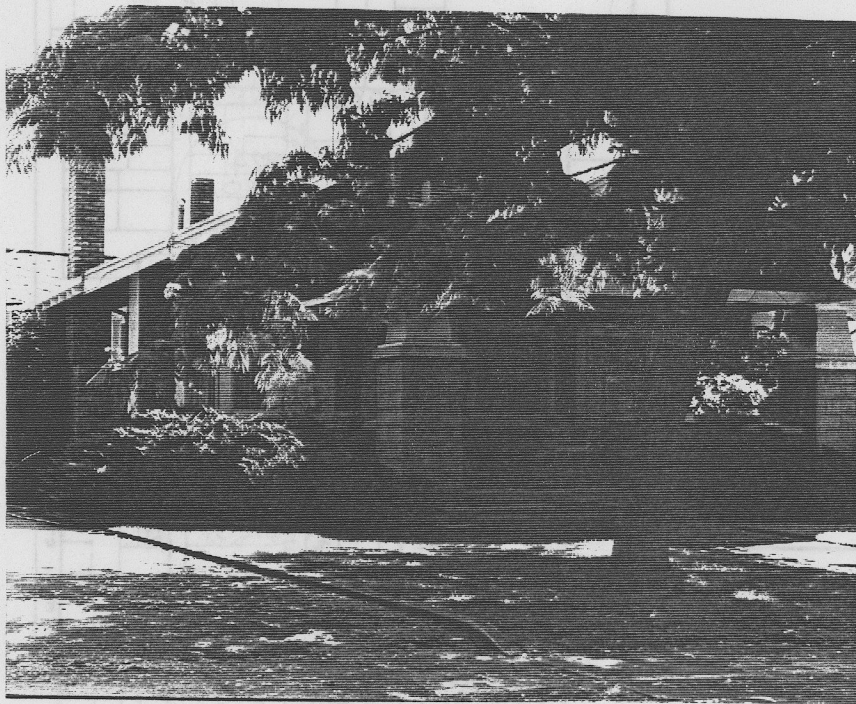
This one story bungalow has a gable roof and gabled side and rear bays. The roof beams are extended beneath the barge rafter and the ends of the rafters are exposed. The siding is rustic and windows are double-hung or plate glass. The wooden entrance door is paneled with four small panes of plain glass in the upper portion. A gable roof covers the front porch which has a concrete block balustrade. Supporting the porch roof are short, tapered pillars atop concrete block pedestals.

8. Construction date:
Estimated c1920 Factual _____
9. Architect _____
10. Builder _____
11. Approx. property size (in feet)
Frontage 60 Depth 177
or approx. acreage _____
12. Date(s) of enclosed photograph(s)
28 Oct 82 30/18

13. Condition: Excellent Good _____ Fair _____ Deteriorated _____ No longer in existence _____
14. Alterations: _____
15. Surroundings: (Check more than one if necessary) Open land Scattered buildings _____ Densely built-up _____
Residential _____ Industrial _____ Commercial _____ Other: _____
16. Threats to site: None known Private development _____ Zoning _____ Vandalism _____
Public Works project _____ Other: _____
17. Is the structure: On its original site? Moved? _____ Unknown? _____
18. Related features: _____
