HISTORIC RESOURCES INVENTORY

1. Common name: \_\_\_\_\_
2. Historic name: \_\_\_\_\_
3. Street or rural address: 554 Matheson Street  
City Healdsburg, CA Zip 95448 County Sonoma
4. Parcel number: 002-220-12
5. Present Owner: information not available Address: \_\_\_\_\_  
City \_\_\_\_\_ Zip \_\_\_\_\_ Ownership is: Public \_\_\_\_\_ Private \_\_\_\_\_
6. Present Use: \_\_\_\_\_ Original use: \_\_\_\_\_

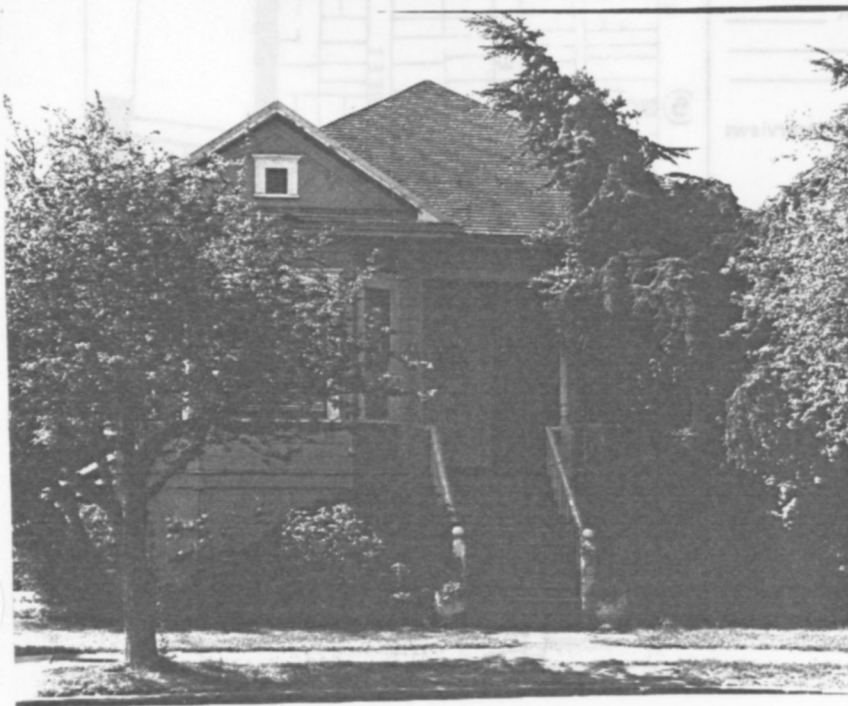
This one story house with a hip roof sits on a raised foundation covered by narrow, vertical bands. The cornice is boxed and the siding is rustic. The closed gable over slanted front bay has a small vent with a molded cap above a slanted shelf and surrounded by narrow boards in a chevron pattern. Windows are double-hung with molded caps. The recessed front porch has turned posts and a molded balustrade. The stair railing has ball topped newel posts at the foot of the stairs. The front door has a round window surrounded by a vine pattern applique above a row of dentils and a molded lower panel. Stairs to a side entrance have a plain railing.

19. Briefly state historical and/or architectural importance (include dates, events, and persons associated with the site.)  
This home has rather restrained ornamentation for a Queen Anne as evidenced by the simply molded balustrade, unbracketed posts and the use of boards laid in a pattern in the gable instead of the cut shingles.
