HISTORIC RESOURCES INVENTORY

1. Common name: _____
2. Historic name: Henry Brown House
3. Street or rural address: 207 North Street
City Healdsburg Zip 95448 County _____
4. Parcel number: 002-161-11
5. Present Owner: Smith, Lucy Address: 207 North St.
City Healdsburg Zip 95448 Ownership is: Public _____ Private X
6. Present Use: Residential Original use: Residential

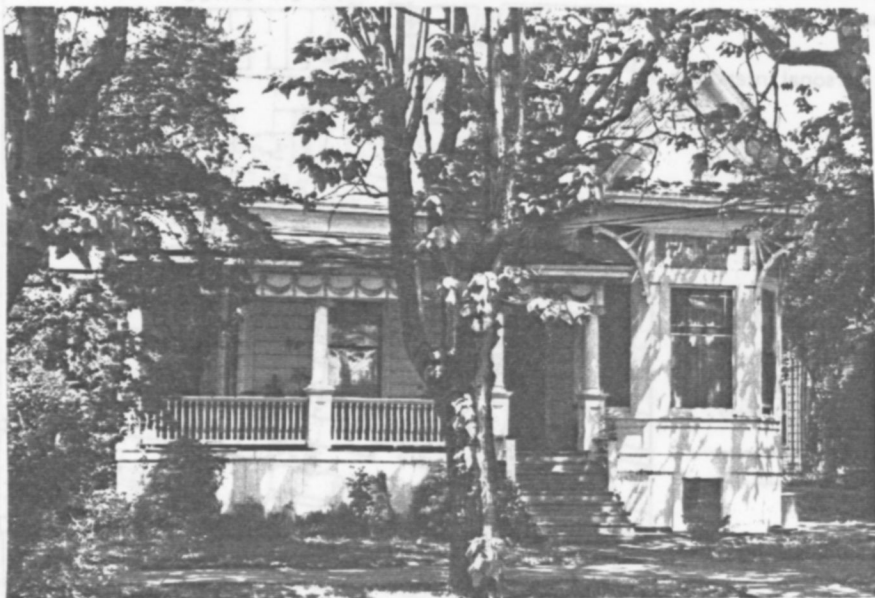
This 1½ story structure has evolved in three phases to its present style. It was originally a gabled homestead style without either the front bay or present front porch. The gabled front bay was added probably in the 90's. The porch, with its turned columns with plaster ionic capitals and plaster garlands, was apparently added at a still later date.
