HISTORIC RESOURCES INVENTORY

1. Common name: _____
2. Historic name: _____
3. Street or rural address: 121 Powell
City Healdsburg, CA Zip 95448 County Sonoma
4. Parcel number: 002-470-35
5. Present Owner: Title Insurance & Trust Co. Address: P.O. Box 546
City Healdsburg, CA Zip 95448 Ownership is: Public _____ Private X
6. Present Use: Residential Original use: Residential

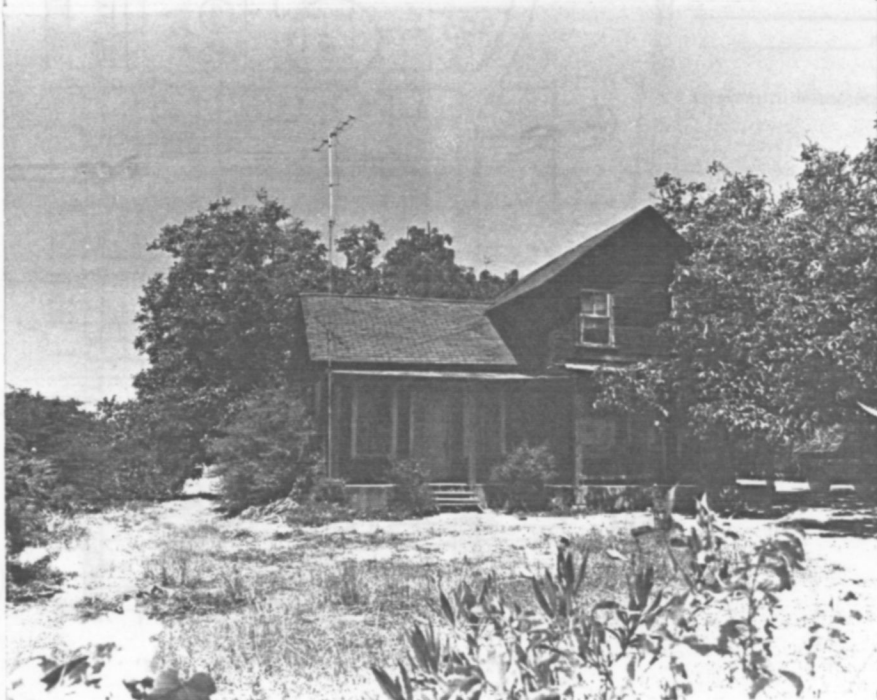
This home has a 1 3/4 story section with a front facing gable and a slightly set back one story section with an end gable. The open gables have closed cornices and no returns. The windows are double-hung with plain frames and placed singly about the structure. The structure's siding is channel rustic with quoins on the corners. Across the front runs a shed roofed verandah with square wooden posts and no balustrade. Each section of the house has a four paneled door facing the street.

13. Condition: Excellent _____ Good _____ Fair _____ Deteriorated X No longer in existence _____
14. Alterations: _____
15. Surroundings: (Check more than one if necessary) Open land X Scattered buildings _____ Densely built-up _____
Residential X Industrial _____ Commercial _____ Other: _____
16. Threats to site: None known _____ X Private development _____ Zoning _____ Vandalism _____
Public Works project _____ Other: _____
17. Is the structure: On its original site? X Moved? _____ Unknown? _____
18. Related features: Board and Batten garage or shed to rear.
