HISTORIC RESOURCES INVENTORY

1. Common name: \_\_\_\_\_
2. Historic name: \_\_\_\_\_
3. Street or rural address: 1610 South Fitch Mountain Road  
City Healdsburg, CA Zip 95448 County Sonoma
4. Parcel number: 087-213-14
5. Present Owner: Hooper, Mario B. Address: \_\_\_\_\_  
City San Francisco, CA Zip 94121 Ownership is: Public \_\_\_\_\_ Private X
6. Present Use: Residential Original use: Residential

- 7a. Architectural style: Vernacular Cabin
- 7b. Briefly describe the present *physical description* of the site or structure and describe any major alterations from its original condition:

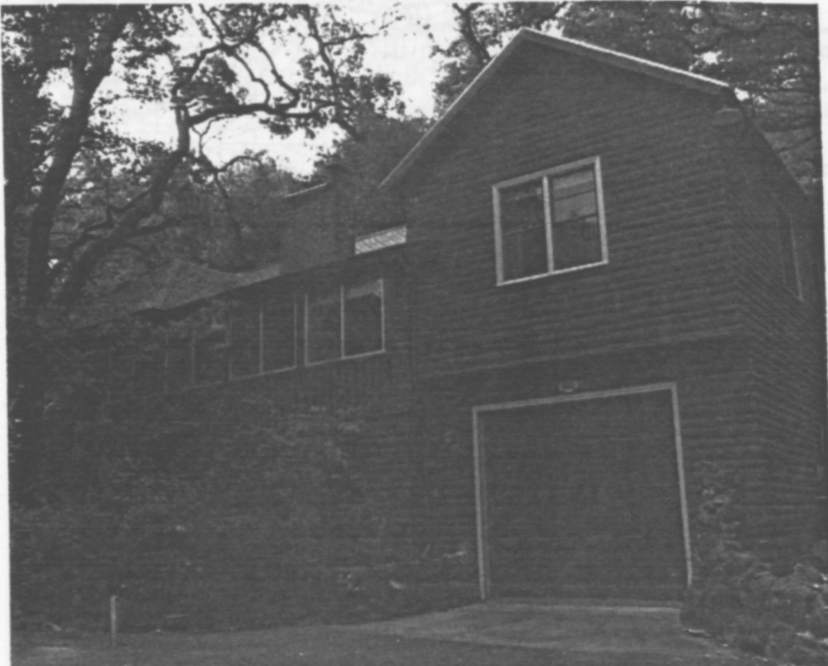
This raised wooden structure has a hip-roofed section adjoining a front-facing gabled section. The house has exposed rafter ends and small brackets beneath the upper level of the gabled section which protrudes slightly in the front. The windows are double-hung with molded frames except for the shed roofed porch which is enclosed with sliding aluminum windows. The exterior is sheathed with a horizontal siding which has alternating wide and narrow bands. Beneath the porch windows there are panels of vertical woodwork. A wide brick chimney pierces the porch roof.

13. Condition: Excellent \_\_\_ Good X Fair \_\_\_ Deteriorated \_\_\_ No longer in existence \_\_\_
14. Alterations: Porch windows
15. Surroundings: (Check more than one if necessary) Open land \_\_\_ Scattered buildings X Densely built-up \_\_\_  
Residential \_\_\_ Industrial \_\_\_ Commercial \_\_\_ Other: \_\_\_
16. Threats to site: None known X Private development \_\_\_ Zoning \_\_\_ Vandalism \_\_\_  
Public Works project \_\_\_ Other: \_\_\_
17. Is the structure: On its original site? X Moved? \_\_\_ Unknown? \_\_\_
18. Related features: \_\_\_
