HISTORIC RESOURCES INVENTORY

1. Common name: _____
2. Historic name: _____
3. Street or rural address: 1615 South Fitch Mountain Road
City Healdsburg, CA Zip 95448 County Sonoma
4. Parcel number: 087-213-99
5. Present Owner: information not available Address: _____
City _____ Zip _____ Ownership is: Public _____ Private X
6. Present Use: Residential Original use: Residential

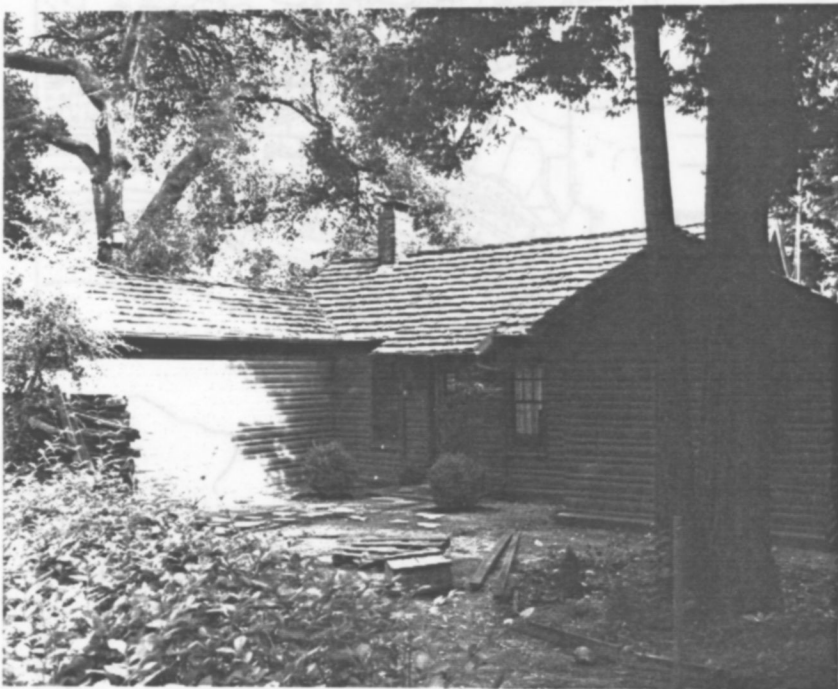
This one-story house has a center section with gabled ends and side additions with front facing gables. The rafters are exposed but the ends are concealed by a fascia board. The open gables have decoratively sawn barge boards. Windows are double hung and the front door has a lattice pattern. A small roof extension over the door is supported by sawn brackets. The wooden siding has an interesting rounded profile with alternating wide and narrow courses.

13. Condition: Excellent _____ Good Fair _____ Deteriorated _____ No longer in existence _____
14. Alterations: _____
15. Surroundings: (Check more than one if necessary) Open land _____ Scattered buildings _____ Densely built-up _____
 Residential Industrial _____ Commercial _____ Other: _____
16. Threats to site: None known Private development _____ Zoning _____ Vandalism _____
 Public Works project _____ Other: _____
17. Is the structure: On its original site? Moved? _____ Unknown? _____
18. Related features: _____
