HISTORIC RESOURCES INVENTORY

1. Common name: _____
2. Historic name: _____
3. Street or rural address: 323 Tucker Street
City Healdsburg, CA Zip 95448 County Sonoma
4. Parcel number: 002-231-32-2
5. Present Owner: Mutruk, Elaine Address: 1940 Straits View Dr.
City Tiburon, CA Zip 94965 Ownership is: Public _____ Private X
6. Present Use: Residential Original use: Residential

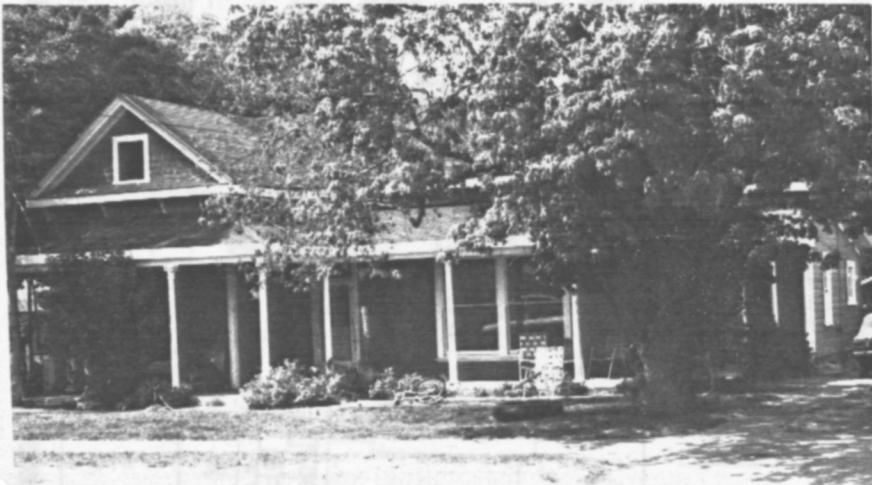
A single story cottage with an H-shaped outline. The house has an offset front gable and a side gable. There is a shed roof on a back addition and the verandah is covered by a hip roof. The boxed cornice on the main structure has sawn brackets beneath it. The gables, closed in the front with a multi-paned colored glass window, and the open side gable, are both filled with cut shingles. The structure has channel rustic siding and double-hung windows. There is a transom over the front door. The verandah roof wraps around the front and side and is supported by slender columns with Corinthian capitals.

13. Condition: Excellent Good _____ Fair _____ Deteriorated _____ No longer in existence _____
14. Alterations: rear volumes possible additions
15. Surroundings: (Check more than one if necessary) Open land _____ Scattered buildings _____ Densely built-up _____
Residential Industrial _____ Commercial _____ Other: _____
16. Threats to site: None known _____ Private development _____ Zoning _____ Vandalism _____
Public Works project _____ Other: _____
17. Is the structure: On its original site? _____ Moved? _____ Unknown? _____
18. Related features: Large liquid amber trees in front.

The most notable feature on this house is its wrap around verandah with Corinthian capital columns instead of the usual turned posts.
