HISTORIC RESOURCES INVENTORY

1. Common name: Silzle Ranch
2. Historic name: Goddard Ranch
3. Street or rural address: 4296 Westside Road
City Healdsburg, CA Zip 95448 County Sonoma
4. Parcel number: 110-100-22-9
5. Present Owner: Sonoma Vineyards Address: P.O. Box 368
City Windsor, CA Zip 95492 Ownership is: Public _____ Private X
6. Present Use: Residential Original use: Residential

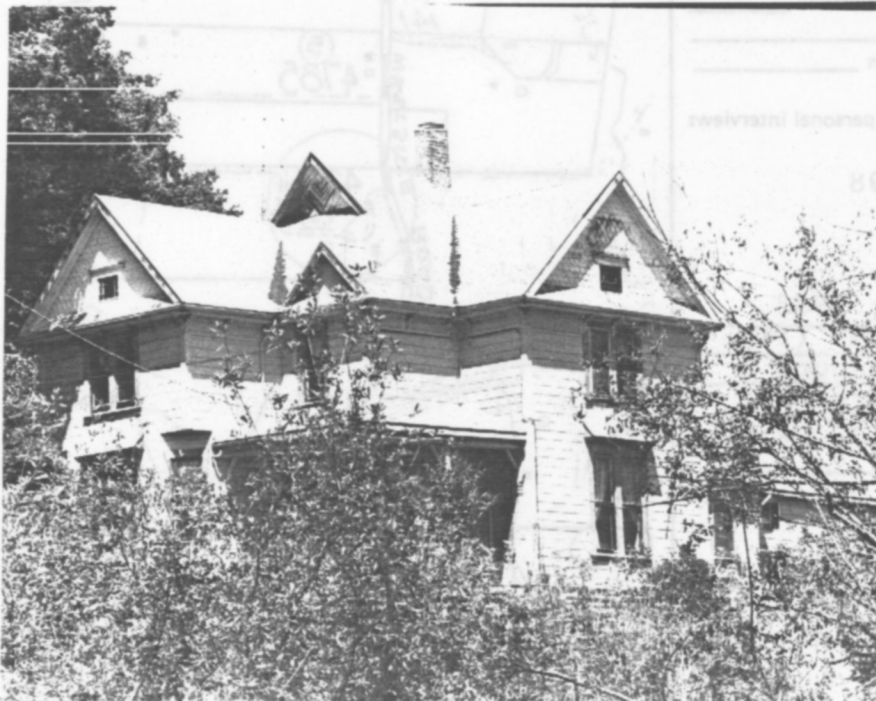
This two-story house has a hip roof with two front gables and two-story gabled bays, one in front and one on the side. The house has a boxed cornice with sawn brackets. The closed gables have slanted shelves, small windows with colored panes, and cut shingles. The gables are filled in with boards laid in a chevron pattern. Windows are double-hung with sill blocks and some have bracketed awnings of cut shingles. The front bay is slanted on the bottom and square above. The front porch wraps one corner and has turned posts and straight brackets. The siding is channel rustic. In the rear is a one-story addition.

13. Condition: Excellent _____ Good _____ Fair _____ Deteriorated X No longer in existence _____
14. Alterations: few
15. Surroundings: (Check more than one if necessary) Open land _____ Scattered buildings _____ Densely built-up _____
Residential _____ Industrial _____ Commercial _____ Other: _____
16. Threats to site: None known _____ Private development _____ Zoning _____ Vandalism _____
Public Works project _____ Other: _____
17. Is the structure: On its original site? X Moved? _____ Unknown? _____
18. Related features: Barns, worker houses, vineyard

This residence has an unusually large scale for its type. It also retains some unusual features such as a slanted bay underneath a square bay.
