HISTORIC RESOURCES INVENTORY

1. Common name: Madrona Manor
2. Historic name: Paxton Ranch Stables
3. Street or rural address: 1001 Westside Road
City Healdsburg, CA Zip 95448 County Sonoma
4. Parcel number: 110-010-41
5. Present Owner: Muir, John Address: P.O. Box 818
City Healdsburg, CA Zip 95448 Ownership is: Public _____ Private X
6. Present Use: Commercial Original use: Private non-comm

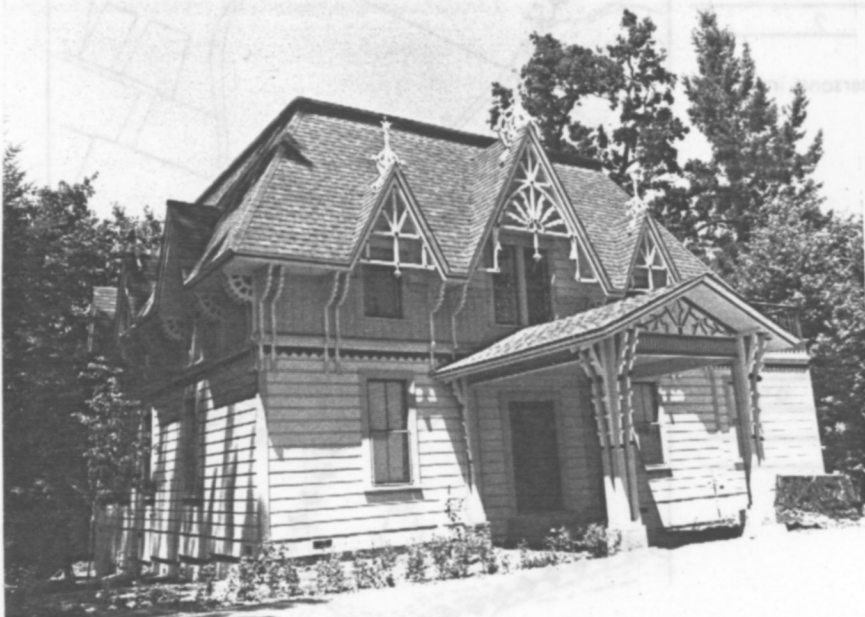
- 7a. Architectural style: Second Empire (Carriage House)
- 7b. Briefly describe the present *physical description* of the site or structure and describe any major alterations from its original condition:
A $1\frac{1}{2}$ story square structure with many gables on its mansard-like roof. To one side is a flat roofed one-story addition with balustraded top. The molded cornice is boxed and the frieze has vertical stickwork above a molded and sawn belt course. Beneath the cornice are pairs of long-tailed brackets which resemble a quarter of a cog wheel. Many of the gable stickwork braces are sawn and turned finials. The gables are filled in with the same channel rustic siding as the walls. Windows are single pane or double-hung. Those in the gables have molded caps. The entrance is protected by a gable roof supported by groups of posts with sawn braces. A cut-out panel fills the gable.

13. Condition: Excellent Good Fair Deteriorated No longer in existence
14. Alterations: Front door; interior
15. Surroundings: (Check more than one if necessary) Open land Scattered buildings Densely built-up
Residential Industrial Commercial Other:
16. Threats to site: None known Private development Zoning Vandalism
Public Works project Other:
17. Is the structure: On its original site? Moved? Unknown?
18. Related features: See main house (110-010-41)
