HISTORIC RESOURCES INVENTORY

1. Common name: _____
2. Historic name: Cook Hardware
3. Street or rural address: 318 & 320 Center Street
City Healdsburg, Ca Zip 95448 County Sonoma
4. Parcel number: 002-194-06-6
5. Present Owner: Schaffer Nancy Warren Address: 645 San Antonio Avenue
City San Diego Ca Zip 92106 Ownership is: Public _____ Private X
6. Present Use: commercial Original use: commercial

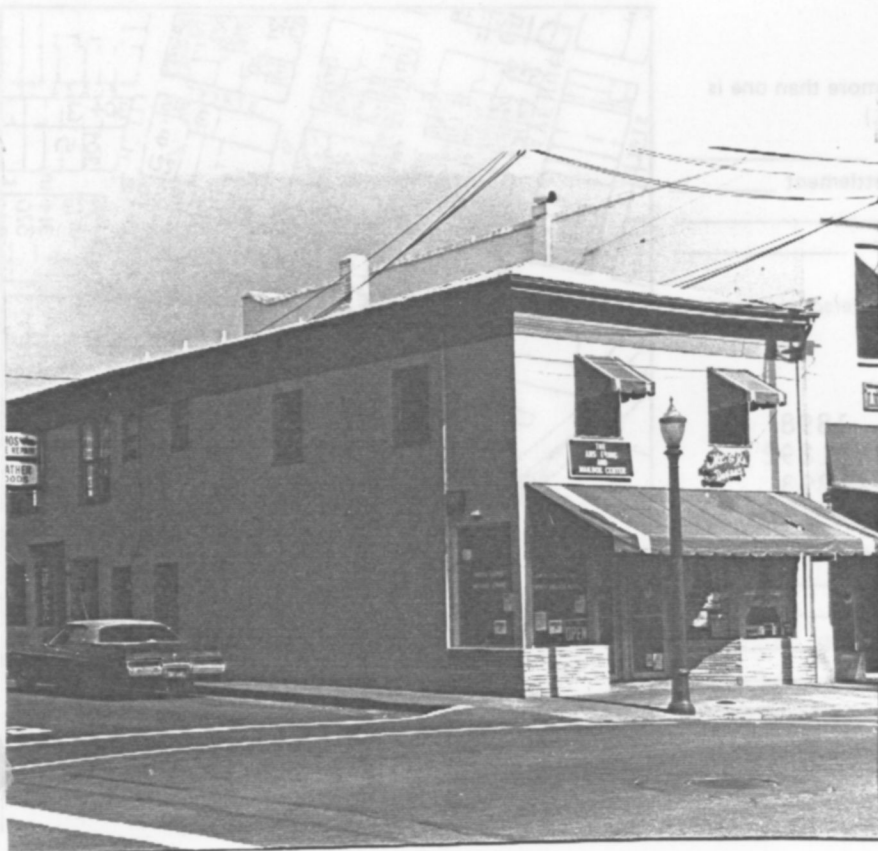
This building has suffered several major misguided improvements to its original state. The main cornice soffit has been retained along with the freeze board with the cornice brackets having been removed. The windows are double hung wood on the second floor but have been altered from their original proportion (circa 1890 photo). The balance of the exterior has been stuccoed over and a stone veneer and aluminum windows added.
