**HISTORIC RESOURCES INVENTORY**

1. Common name: \_\_\_\_\_
2. Historic name: \_\_\_\_\_
3. Street or rural address: 227 Fitch Street  
City Healdsburg Zip 95448 County \_\_\_\_\_
4. Parcel number: 002-232-05
5. Present Owner: Ellis, Wilma et.al. Address: 227 Fitch Street  
City Healdsburg Zip 95448 Ownership is: Public \_\_\_\_\_ Private X
6. Present Use: Residential Original use: Residential

- 7a. Architectural style: Queen Anne Cottage
- 7b. Briefly describe the present *physical description* of the site or structure and describe any major alterations from its original condition:

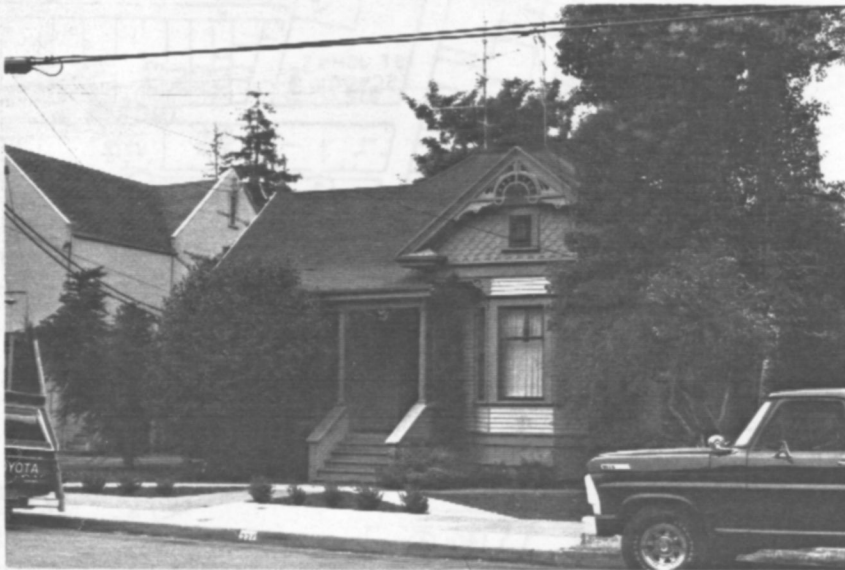
This one story cottage with angled bay window has a shingled gable above with a sawn and turned gable brace. Turned columns support the porch roof.

The bay on this house is an especially nice example of the Queen Anne style with its tall, narrow windows, cut shingles and stained glass gable window and sawn and spindled gable brace.
