HISTORIC RESOURCES INVENTORY

1. Common name: _____
2. Historic name: John McClish House
3. Street or rural address: 325 Fitch Street
City Healdsburg, CA Zip 95448 County Sonoma
4. Parcel number: 002-192-09-4
5. Present Owner: Cunningham, Frank E. & Martha E. Address: 325 Fitch Street
City Healdsburg, CA Zip 95448 Ownership is: Public _____ Private X
6. Present Use: Residential Original use: Residential

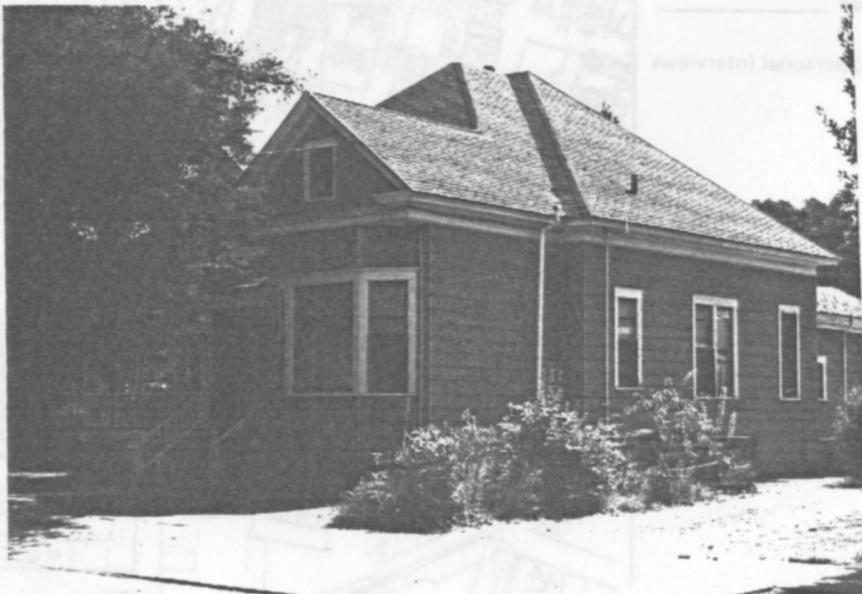
This one storey house has a hip and gable roof with boxed cornice. The gable has a multi-lite fixed sash window and partial cornice returns. The original siding and gable finish has been covered over with asbestos siding. A large curved verandah extends across the front and side atop decoratively turned pillars. Turned post with small brackets support the hip roof with a molded balustrade system.

13. Condition: Excellent ___ Good X Fair ___ Deteriorated ___ No longer in existence ___
14. Alterations: Asbestos siding
15. Surroundings: (Check more than one if necessary) Open land ___ Scattered buildings ___ Densely built-up ___
Residential X Industrial ___ Commercial ___ Other: ___
16. Threats to site: None known X Private development ___ Zoning ___ Vandalism ___
Public Works project ___ Other: ___
17. Is the structure: On its original site? X Moved? ___ Unknown? ___
18. Related features: Redwood tree near curb planted by owners 1902.
