### HISTORIC RESOURCES INVENTORY

1. Common name: First Baptist Church
2. Historic name: First Baptist Church
3. Street or rural address: 431 Fitch Street  
City Healdsburg Zip 95448 County Sonoma
4. Parcel number: 002-161-16
5. Present Owner: First Baptist Church of Healdsburg Address: 311 North Street  
City Healdsburg Zip 95448 Ownership is: Public \_\_\_\_\_ Private X
6. Present Use: Church Original use: Church

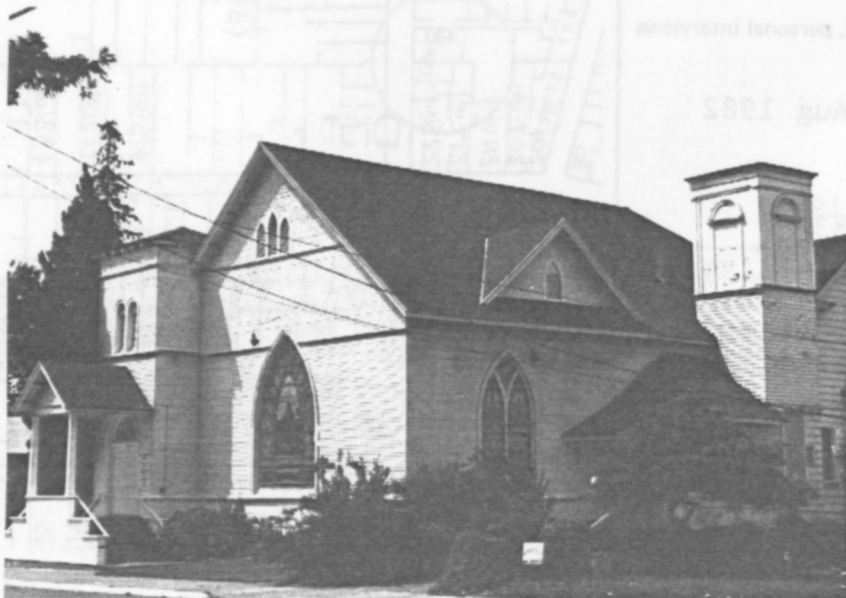
The First Baptist Church of Healdsburg consists of two buildings: one at the rear is a Greek Revival Church dated in 1856 and added to it in 1908 is the larger Gothic Revival building facing Fitch Street. The front of the Greek Revival Church is flanked by two square towers; one truncated at the belfry level and one level with the eaves. Both towers contain high arched windows presently boarded up.

The Gothic Revival Church has high gothic arched stained glass windows and another square tower truncated at the eave level. Windows in the tower are round arches. The entrance to the main church is in this tower. Above the double doors is a stained glass transom inscribed, "First Baptist Church 1908".

\*Note: since time of photo 116 year old tower at rear removed (1984) by owner
