HISTORIC RESOURCES INVENTORY

1. Common name: _____
2. Historic name: Gunn House
3. Street or rural address: 518 Fitch Street
City Healdsburg Zip 95448 County Sonoma
4. Parcel number: 002-121-28
5. Present Owner: Alves, Duane & Susan Address: 518 Fitch Street
City Healdsburg Zip 95448 Ownership is: Public _____ Private X
6. Present Use: Residential Original use: Residential

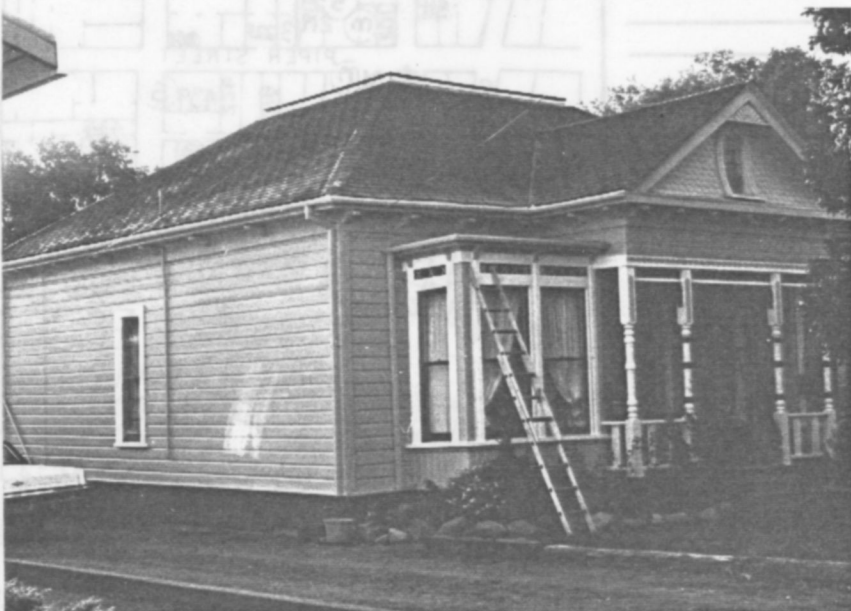
This one-story cottage has a boxed cornice with elongated sawn brackets over a plain frieze. A large gabled pediment accentuates the central entryway. The gable has an ornamental window with a sunburst gable and filled in with cut shingles. Turned columns with brackets and fretwork between support the entry gable. The balustrade system has been altered. Two bay windows flanking the entryway have flat roofs with bracketed cornice.

13. Condition: Excellent ___ Good X Fair ___ Deteriorated ___ No longer in existence ___
14. Alterations: windows
15. Surroundings: (Check more than one if necessary) Open land ___ Scattered buildings ___ Densely built-up ___
Residential X Industrial ___ Commercial ___ Other: ___
16. Threats to site: None known X Private development ___ Zoning ___ Vandalism ___
Public Works project ___ Other: ___
17. Is the structure: On its original site? X Moved? ___ Unknown? ___
18. Related features: ___
