HISTORIC RESOURCES INVENTORY

1. Common name: Scalione Realty
2. Historic name: Clack House
3. Street or rural address: 411 Foss Street
City Healdsburg, Ca. Zip 95448 County Sonoma
4. Parcel number: 002-173-22-7
5. Present Owner: Scalione Charles & Inez Address: p.o. box 486
City Healdsburg, Ca Zip 95448 Ownership is: Public _____ Private X
6. Present Use: commercial Original use: residential

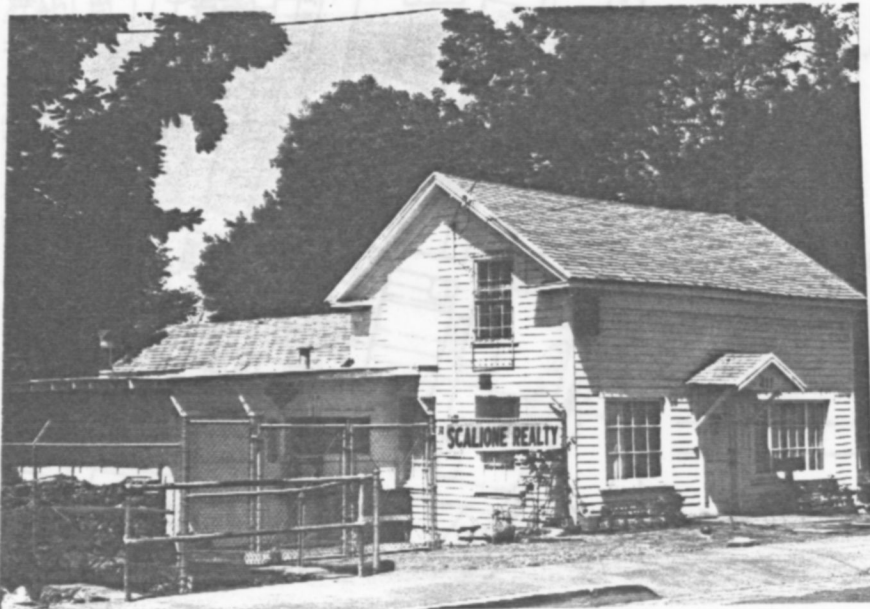
This 1½ story house has a one story wing in the rear and a later shed addition to the left side. The gables are open with boxed cornices with returns. There are multi-paned double hung windows in the gable ends, and the front windows appear to have been altered to a different proportion with multi-paned fixed sash. There is a small gabled portico over the front door which appears to be a later addition.

13. Condition: Excellent ___ Good ___ Fair ___ Deteriorated X No longer in existence ___
14. Alterations: _____
15. Surroundings: (Check more than one if necessary) Open land ___ Scattered buildings ___ Densely built-up ___
Residential XX Industrial ___ Commercial XX Other: _____
16. Threats to site: None known X Private development ___ Zoning ___ Vandalism ___
Public Works project ___ Other: _____
17. Is the structure: On its original site? X Moved? ___ Unknown? ___
18. Related features: _____
