HISTORIC RESOURCES INVENTORY

1. Common name: _____
2. Historic name: John Long Barn
3. Street or rural address: 18605 Geyserville Avenue
City Geyserville, CA Zip 95441 County Sonoma
4. Parcel number: 140-010-16
5. Present Owner: Fredson, Leonard & Donald W. Address: 1020 Alexander Valley Rd
City Healdsburg, CA Zip 95448 Ownership is: Public _____ Private X
6. Present Use: Commercial Original use: Barn

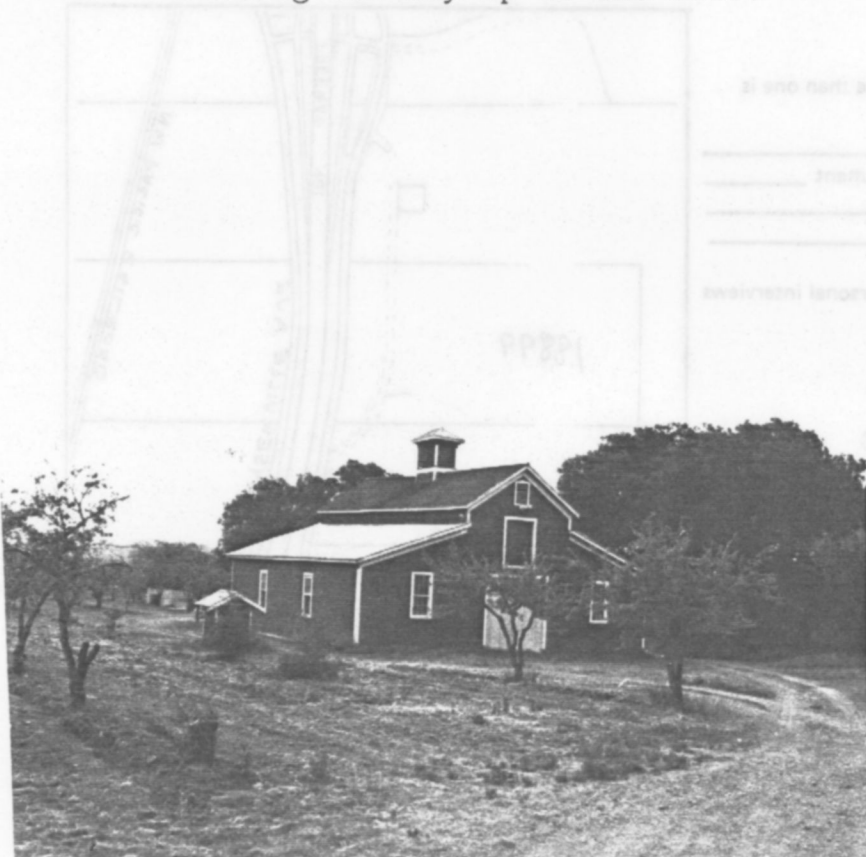
8. Construction date:
Estimated 1880 Factual _____
9. Architect _____
10. Builder _____
11. Approx. property size (in feet)
Frontage _____ Depth _____
or approx. acreage 16.42
12. Date(s) of enclosed photograph(s)
18 Apr 83 55/13

This barn has matching shed roofed wings on either side of a two-story center section whose gable roof slopes down to just above the roofs of the wings. Centered on the ridge of the gable is a vented cupola. The barn has closed cornices and rustic siding. Windows are multi-paned double-hungs. The center section has a large first-story opening and a smaller hay loft door above. Just below the peak of the gable is a vent and a beam that aided in hoisting the hay up to the loft.

13. Condition: Excellent _____ Good Fair _____ Deteriorated _____ No longer in existence _____
14. Alterations: _____
15. Surroundings: (Check more than one if necessary) Open land Scattered buildings _____ Densely built-up _____
Residential _____ Industrial _____ Commercial _____ Other: _____
16. Threats to site: None known Private development _____ Zoning _____ Vandalism _____
Public Works project _____ Other: _____
17. Is the structure: On its original site? Moved? _____ Unknown? _____
18. Related features: _____
