HISTORIC RESOURCES INVENTORY

1. Common name: _____
2. Historic name: William Bell Home
3. Street or rural address: 521 Grant Avenue
City Healdsburg, CA Zip 95448 County Sonoma
4. Parcel number: 086-020-04
5. Present Owner: Bagge, William Address: 521 Grant Avenue
City Healdsburg, CA Zip 95448 Ownership is: Public _____ Private X
6. Present Use: Residential Original use: Residential

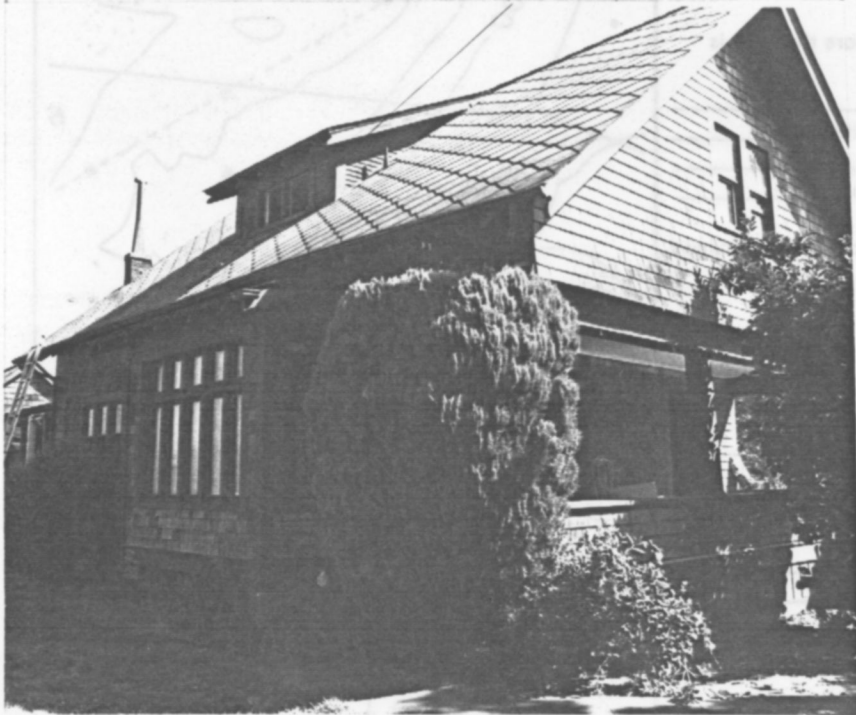
This one story home has a single gable roof with the open ends at the front and back. The barge board and exposed rafters have decorative ends as do the rafters of the shed roof dormers. The windows are double-hung except for those in the dormer and the Prairie style windows in a rectangular side bay. A pair of windows in the front gable have diamond shaped panes in the upper sash. The recessed front porch has tapered square columns atop a solid balustrade. The entire structure is covered with wood shingles including the balustrade and rear additions.

13. Condition: Excellent Good _____ Fair _____ Deteriorated _____ No longer in existence _____
14. Alterations: _____
15. Surroundings: (Check more than one if necessary) Open land Scattered buildings _____ Densely built-up _____
Residential Industrial _____ Commercial _____ Other: _____
16. Threats to site: None known Private development _____ Zoning _____ Vandalism _____
Public Works project _____ Other: _____
17. Is the structure: On its original site? Moved? _____ Unknown? _____
18. Related features: _____
