HISTORIC RESOURCES INVENTORY

1. Common name: _____
2. Historic name: Koenig Building
3. Street or rural address: 330 Healdsburg Avenue
City Healdsburg Ca Zip 95448 County Sonoma
4. Parcel number: 002-181-03-0
5. Present Owner: Combs, Fred F Address: 330 Healdsburg Avenue
City Healdsburg Ca Zip 95448 Ownership is: Public _____ Private X
6. Present Use: commercial Original use: commercial

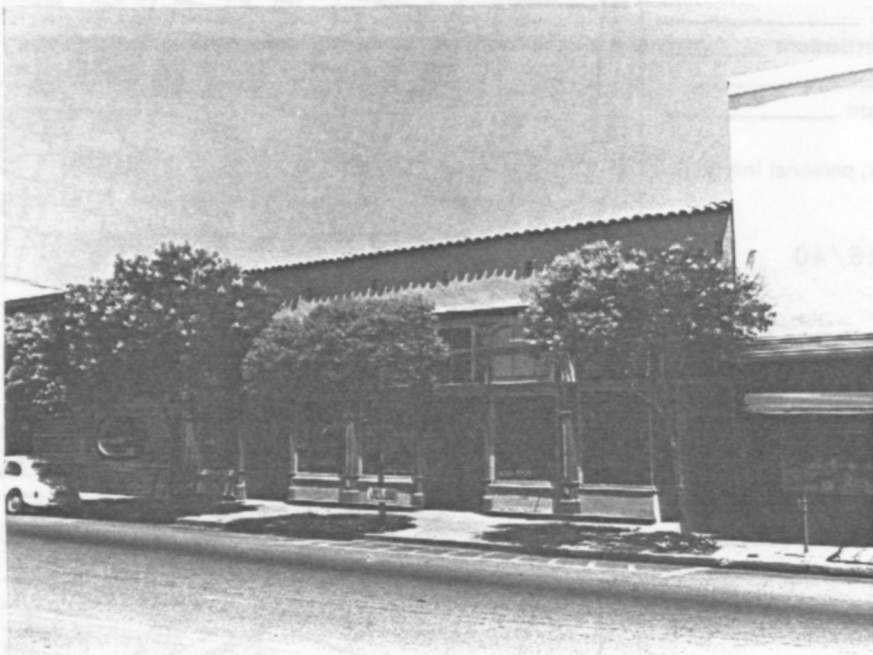
This one-story iron front building is fairly original below the cornice line, the original cornice having been removed. Three recessed entryways pierce the facade and accentuated by round corinthian columns. The balance of the lower facade is completely filled with large fixed glass windows separated by corinthian pilasters. There is a series of "keyed" transom windows crossing the complete facade and topping the windows and doors.

8. Construction date: Estimated 1884 Factual _____
9. Architect _____
10. Builder Frank Koenig
11. Approx. property size (in feet)
Frontage 51 Depth 159.7
or approx. acreage _____
12. Date(s) of enclosed photograph(s)
10 Aug 82 05/11
