HISTORIC RESOURCES INVENTORY

- 1. Common name: _____
- 2. Historic name: _____
- 3. Street or rural address: 542 Johnson Street
City Healdsburg Zip 95448 County Sonoma
- 4. Parcel number: 002-123-08
- 5. Present Owner: Swisher, Anna M. Address: 542 Johnson St.
City Healdsburg Zip 95448 Ownership is: Public _____ Private X
- 6. Present Use: Residential Original use: Residential

- 7a. Architectural style: Italianate Cottage
- 7b. Briefly describe the present *physical description* of the site or structure and describe any major alterations from its original condition:

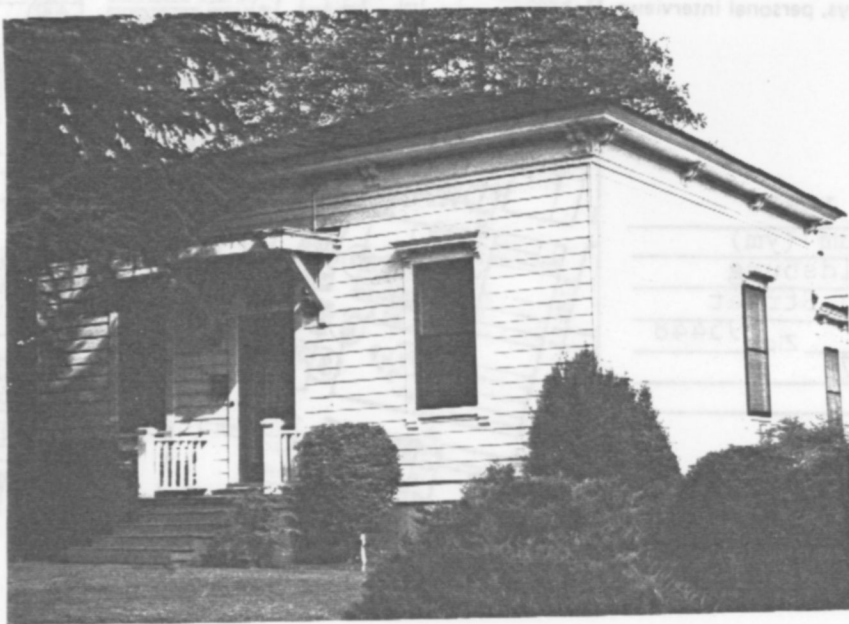
This rectilinear cottage with hipped roof has a boxed cornice with paired sawn brackets over a plain frieze. Double hung windows are placed singly around the structure and are capped with small flat hoods with sawn brackets and sill blocks underneath. The entry portico has been altered and the front door changed to a french door. The siding is channel rustic.

13. Condition: Excellent ___ Good Fair ___ Deteriorated ___ No longer in existence ___
14. Alterations: _____
15. Surroundings: (Check more than one if necessary) Open land ___ Scattered buildings ___ Densely built-up ___
Residential Industrial ___ Commercial ___ Other: _____
16. Threats to site: None known Private development ___ Zoning ___ Vandalism ___
Public Works project ___ Other: _____
17. Is the structure: On its original site? Moved? ___ Unknown? ___
18. Related features: large spruce tree
