HISTORIC RESOURCES INVENTORY

1. Common name: _____
2. Historic name: William Knox House
3. Street or rural address: 407 Matheson Street
City Healdsburg, CA Zip 95448 County Sonoma
4. Parcel number: 002-201-45-7
5. Present Owner: Mc Clish, Glenn A. Address: 614 Fitch Street
City Healdsburg, CA Zip 95448 Ownership is: Public _____ Private X
6. Present Use: Residential Original use: Residential

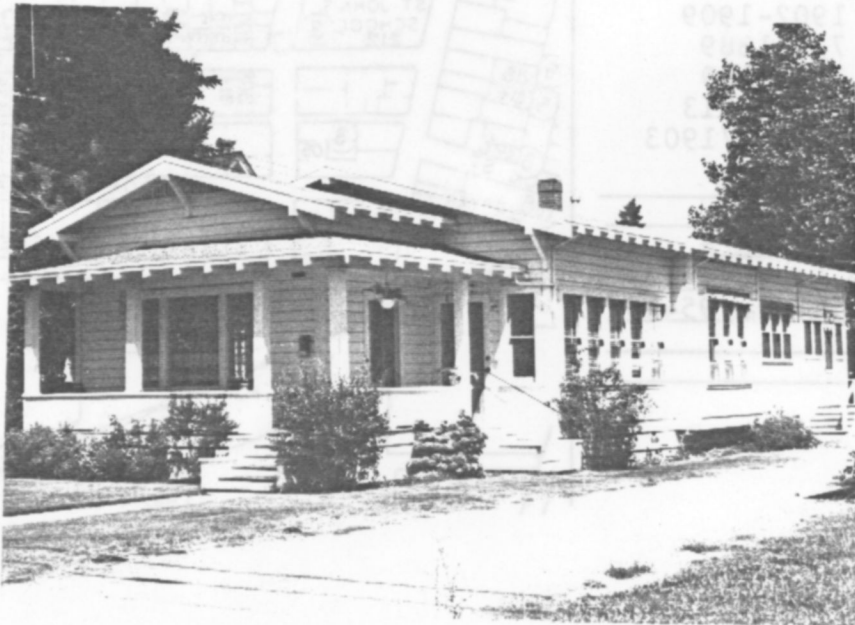
This one story house has a gabled roof with open rafters and open brackets supporting the barge rafter. The hip roofed verandah wraps the front and part of the side. It also is constructed with open rafters and has square constructed columns atop a solid balustrade. The siding is rustic and numerous double hung windows are set in groupings around the structure.
