HISTORIC RESOURCES INVENTORY

1. Common name: _____
2. Historic name: _____
3. Street or rural address: 412 North Street
City Healdsburg, CA Zip 95448 County Sonoma
4. Parcel number: 002-201-29-1
5. Present Owner: Smith, Suzanne R. Address: 412 North Street
City Healdsburg, CA Zip 95448 Ownership is: Public _____ Private X
6. Present Use: Residential Original use: Residential

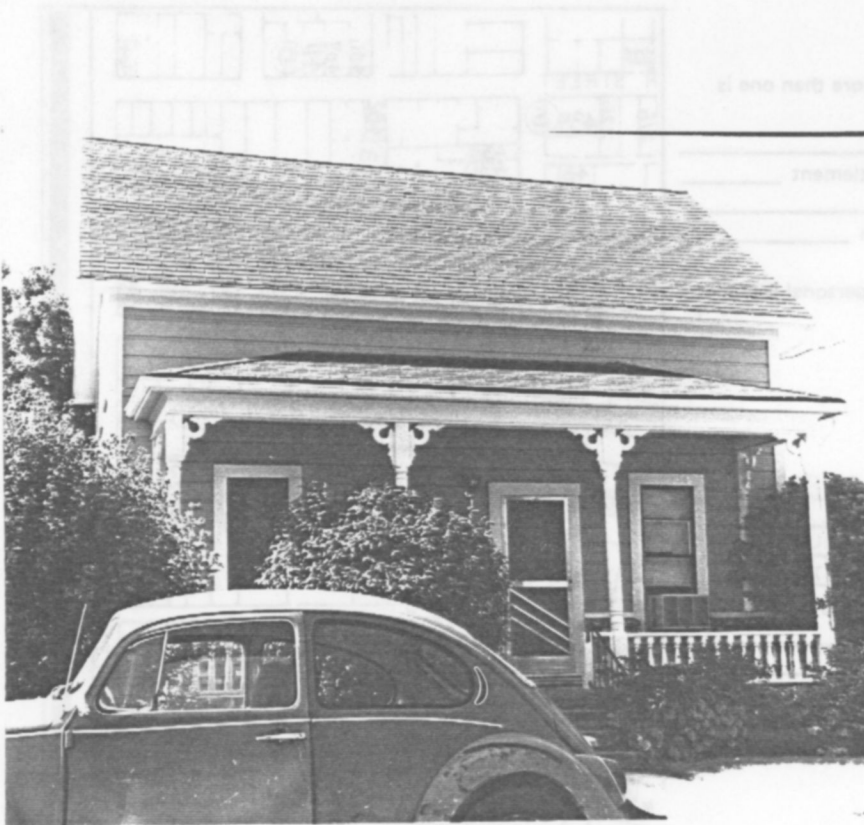
A rectangular 1½ story home with open gable ends and channel rustic siding. The cornice is boxed and windows are double-hung. The front appears to have had some alteration such as the current placement of the front door and the addition of used brick below the window level. The hipped roof front porch has bracketed, turned posts, and a railing with turned balusters. The metal stair railing is not original.

13. Condition: Excellent _____ Good X Fair _____ Deteriorated _____ No longer in existence _____
14. Alterations: _____
15. Surroundings: (Check more than one if necessary) Open land _____ Scattered buildings _____ Densely built-up _____
Residential X Industrial _____ Commercial _____ Other: _____
16. Threats to site: None known X Private development _____ Zoning _____ Vandalism _____
Public Works project _____ Other: _____
17. Is the structure: On its original site? X Moved? _____ Unknown? _____
18. Related features: Used brick facing on lower front wrought iron banister and front door.
