HISTORIC RESOURCES INVENTORY

1. Common name: _____
2. Historic name: _____
3. Street or rural address: 445 North Street
City Healdsburg Zip 95448 County Sonoma
4. Parcel number: 002-151-36
5. Present Owner: Saylor, Daniel & Hazel Address: 530 Prince Ave.
City Healdsburg Zip 95448 Ownership is: Public _____ Private X
6. Present Use: Residential Original use: Residential

- 7a. Architectural style: Transitional Bungalow
- 7b. Briefly describe the present *physical description* of the site or structure and describe any major alterations from its original condition:

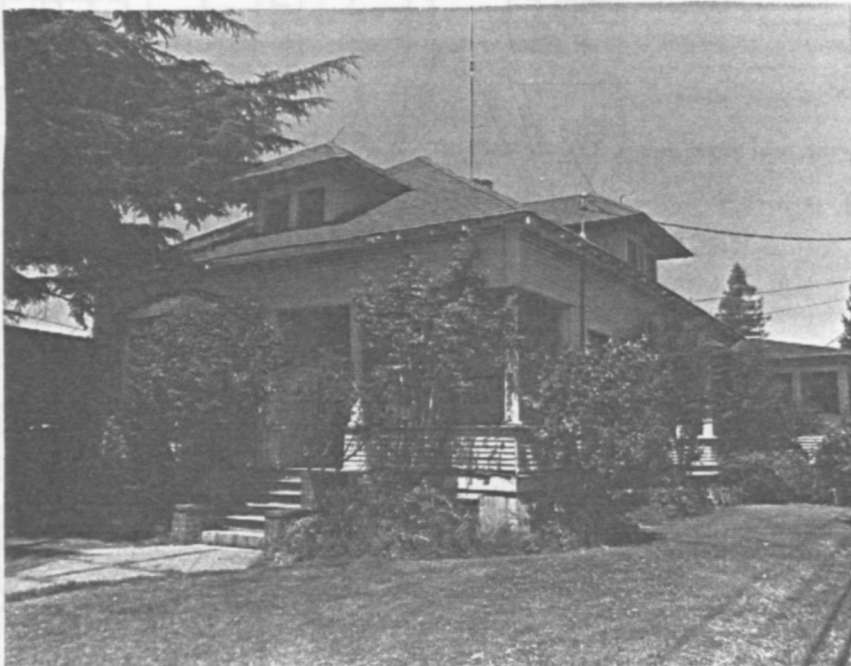
This one-story cottage has a hip roof with hipped roof dormers. The front dormer has two fixed sash and the side dormer has 2 sash with a vent. The rafter tails open and are decoratively sawn. There is a front and side angled bay with hip roof ending under the main eaves. There is a large rectangular bay of similar design on the side. There is a small entry porch recessed under the main roof which is supported by turned columns atop a solid balustrade. The siding is narrow rustic.
