HISTORIC RESOURCES INVENTORY

1. Common name: _____
2. Historic name: Ames Home
3. Street or rural address: 407 Piper Street
City Healdsburg Zip 95448 County Sonoma
4. Parcel number: 002-133-22-1
5. Present Owner: Johnson, Clyde & Margaret Address: 407 Piper Street
City Healdsburg Zip 95448 Ownership is: Public _____ Private X
6. Present Use: Residential Original use: Residential

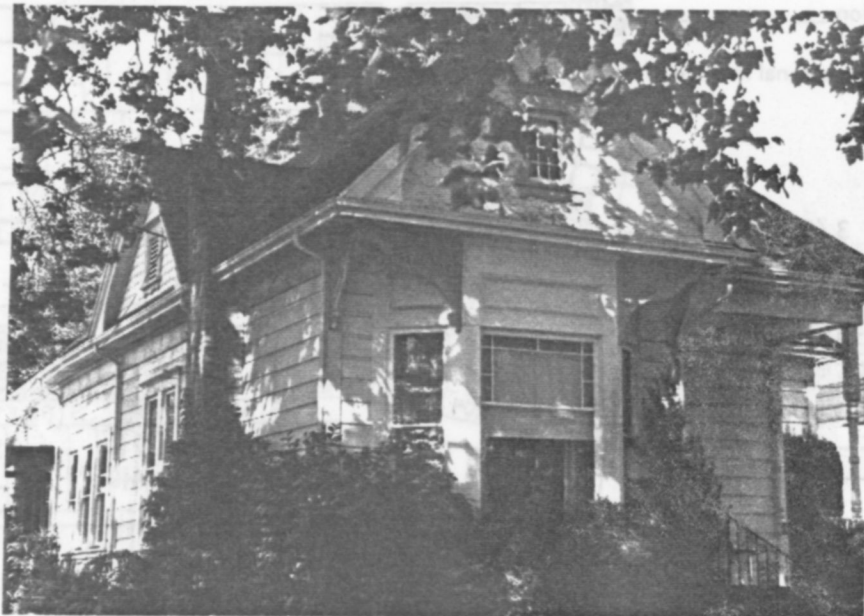
This small one-story cottage has a combination of hip and gabled roof. The gables contain either multi-lite fixed sash windows or gabled vents and are filled in with cut shingles, flared at the bottom, with a simple bargeboard. The windows are double hung with small cap molding on some. The siding is channel rustic, and the front gable has a narrow angled bay underneath, with large angle brackets with a sunburst motif. The small entry porch is recessed under the main roof and has turned columns. The original porch brackets and balustrade system is missing.

This is a good example of Queen Anne cottage architecture, showing the reliance on the narrow gabled bay, with its wide sunburst brackets, to be the focal point of the exterior design. The Charles Ames home was built circa 1890. It is most noted for being the home of Charles Ames' daughter, Nercilla Ames Jones, R.N., who served as director of Healdsburg General Hospital from 1920 until her retirement in 1965. During her 45 years as director, Nercilla became one of the best-known, and most trusted, residents of Healdsburg.
