HISTORIC RESOURCES INVENTORY

1. Common name: _____
2. Historic name: Frank A. Petray House
3. Street or rural address: 1081 South Fitch Mountain Road
City Healdsburg, CA Zip 95448 County Sonoma
4. Parcel number: 002-511-41
5. Present Owner: Rotlisberger, George C. Address: 1081 S. Fitch Mt. Road
City Healdsburg, CA Zip 95448 Ownership is: Public _____ Private X
6. Present Use: Residential Original use: Residential

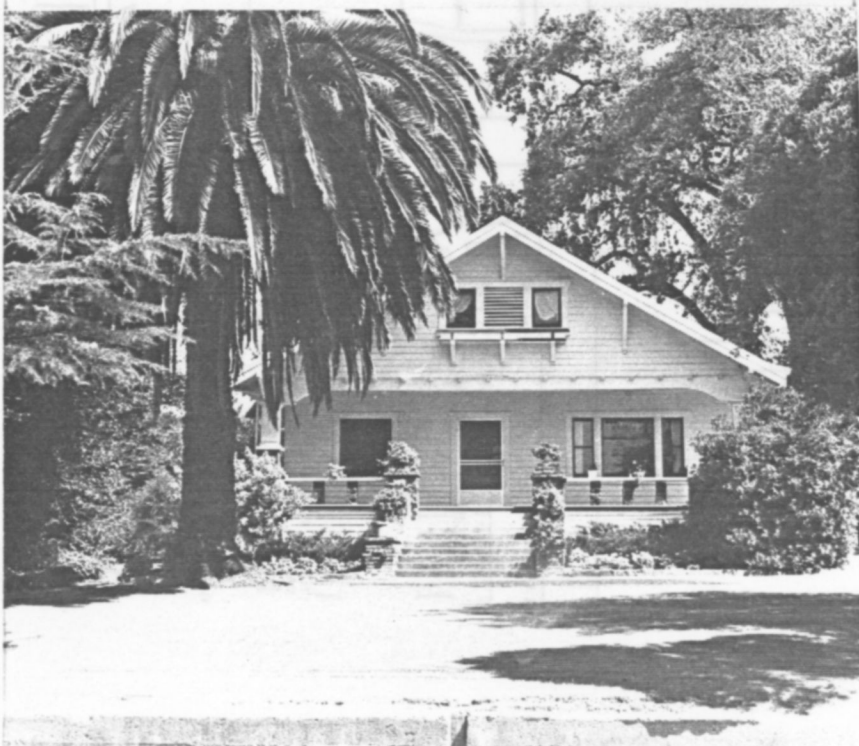
This large, one-story bungalow has a wide gable roof which faces the street. The tails of the rafters are exposed and the gable's barge rafter is supported by 5 large braces. A vent between two windows above a bracketed window box is centered in the gable. Across the front of the recessed porch is a large beam whose ends curve down to square corner posts atop pedestals of "clinker" brick. The balustrade has brick posts topped by a wide flat board. Clinker brick also forms newel posts at the top of the concrete stairs which have stepped brick sides. The windows are double-hung and some have diamond shaped panes in the upper sashes. The siding is lap rustic. A porte cochere with square wood columns atop brick pedestals and exposed rafter ends is located on one side of the house as is an exterior chimney of brick.

13. Condition: Excellent Good _____ Fair _____ Deteriorated _____ No longer in existence _____
14. Alterations: _____
15. Surroundings: (Check more than one if necessary) Open land _____ Scattered buildings _____ Densely built-up _____
Residential Industrial _____ Commercial _____ Other: _____
16. Threats to site: None known Private development _____ Zoning _____ Vandalism _____
Public Works project _____ Other: _____
17. Is the structure: On its original site? Moved? _____ Unknown? _____
18. Related features: Large palm tree in front
