HISTORIC RESOURCES INVENTORY

1. Common name: _____
2. Historic name: Walter A. Bowles House
3. Street or rural address: 14 University
City Healdsburg, CA Zip 95448 County Sonoma
4. Parcel number: 002-282-03-6
5. Present Owner: Anello, Carmel & Joseph L. & Robert A. Address: 14 University
City Healdsburg, CA Zip 95448 Ownership is: Public _____ Private X
6. Present Use: Residential Original use: Residential

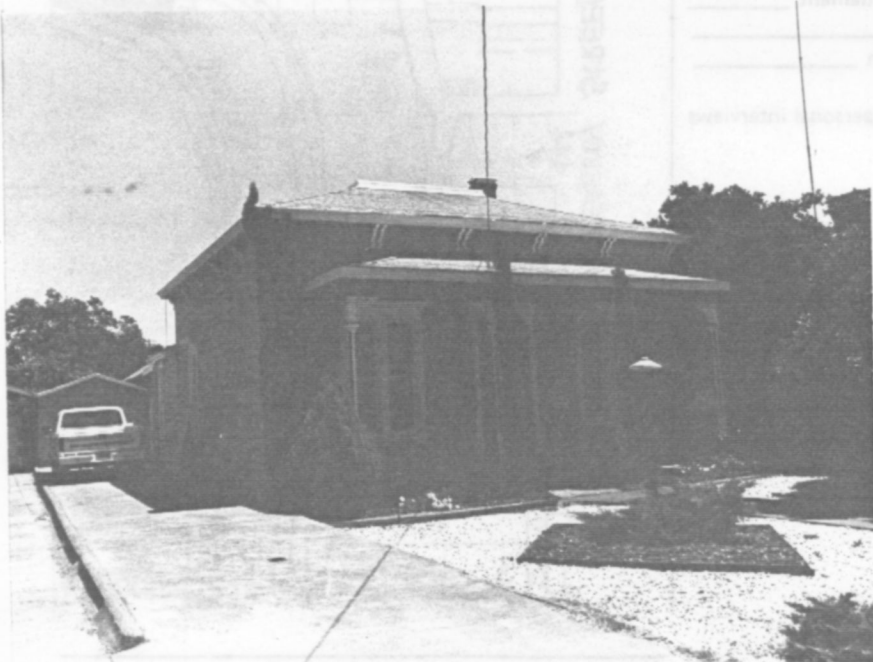
This Italianate cottage has a square hip roof. The boxed cornice and molded frieze has pairs of equally spaced sawn brackets. The windows are tall, narrow double-hungs, found singly and in pairs on either side of the front door. The windows and doorway have bracketed, molded hoods, and sill blocks. The recessed entrance has paneled sides, and a transom over the paneled door with glass inserts. The front porch has a hip roof with elaborately leveled posts and sawn brackets which differ from those on the cornice. In the rear are additions with the same channel rustic siding as the main structure.

19. Briefly state historical and/or architectural importance (include dates, events, and persons associated with the site.)
According to tax assessment records, this house was built by Walter A. Bowles, about whom nothing is known.
This Italianate cottage, of classic design, retains all of its original detailing and porch. In excellent condition, this structure is an unaltered example of its kind.
