HISTORIC RESOURCES INVENTORY

SIGIRIV SHOM	Alterationst
IDENTI 1.	FICATION Common name:	X Scattered built	ecessary) Open land		
2.	Historic name: Maac	ama School	THE REPORT OF THE PARTY OF THE	minor ignition.	Residential
3.	Street or rural address:	14657 Chalk	Hill Road	min <u>x</u> merenal empla merito <u>residente</u>	16. Threats to site: Public Works an
	City Healdsburg.	CA	Zip 95448	County_Sono	ma
4.	Parcel number:132-0	80-12-8			emurbet borsloft - ,81
5.	Present Owner: Bosic	o. June et	al	Address: 1509	5 Grove Street
	City Healdsburg,	CA Zip	95448 Ownersh	nip is: Public	Private X
6.	Present Use: Residen	ntial	Original use:	School House	to 1877 on t

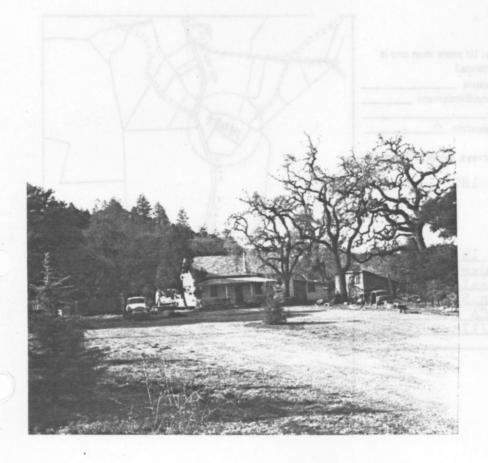
This one-story structure has a gable roof and rustic siding. The cornice is boxed. Windows are double-hung. The front porch has a hip roof with exposed rafter tails supported by plain posts and a crossed rail balustrade. The porch and placement of the current front door may not be original. To one side is a shed roofed addition.

13. Condition: ExcellentGood Fair X Deterior	prated No longer in existence				
14. Alterations: None visible	HISTORIC RESOURCES IN-LENGRY				
15. Surroundings: (Check more than one if necessary) Open la Residential Industrial Commercial Other
