## HISTORIC RESOURCES INVENTORY

DENTIF	Common name:	Manzan	ita Sch	001	ecessary) • Op	n 1i eno nedi e	gs: (Check men	Surroundin	18.
2.	Historic name:	Manzan	ita Sch	001	V	111111111111111111111111111111111111111		10131301313974	
	Street or rural add				Road	durant Transcription	# 8000 1916 109[010 EX	Public War	-01
	City_ Heal	dsburg,	CA	Zip	95448	County_	Sonoma	outes soluci	.71
4.	Parcel number:	089-09	0-42				Landa September	Related tea	.81
5.	Present Owner: _	Mengal	i, Jose	ph and	Kathlee	n Address:	795 Dry	Creek	Road
	City Heald	sburg, C	A	Zip 954	48 Ownershi	p is: Public _	Pri	ivate X	T
6.	Present Use:	Resident	ial		Original use:	School		chool i	8

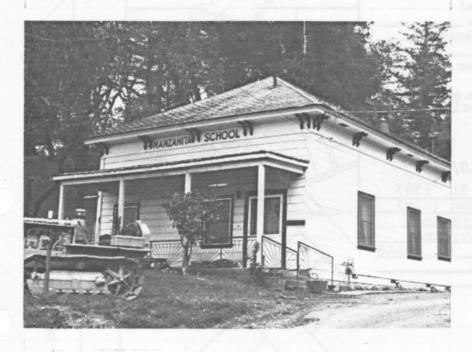
A one-story, hip roofed structure with simple molding on the boxed cornice. Beneath the cornice are evenly spaced pairs of sawn brackets. This box shaped building has channel rustic siding and double-hung windows placed singly and in pairs. The windows may not be original. The front porch roof is supported by plain square posts and has a wrought iron balustrade with a sunburst design. The posts and balustrade may also be a recent addition and/or replacement of the originals. Two other details are simple pilaster like corner boards, and "Manzanita School" painted on the front frieze.
