HISTORIC RESOURCES INVENTORY

1. Common name: _____
2. Historic name: Lewis House
3. Street or rural address: 941 Dry Creek Road
- S City Healdsburg, CA Zip 95448 County Sonoma
4. Parcel number: 089-050-38
5. Present Owner: Camaur, Josephine Address: 941 Dry Creek Road
City Healdsburg, CA Zip 95448 Ownership is: Public _____ Private X
6. Present Use: Residential Original use: Residential

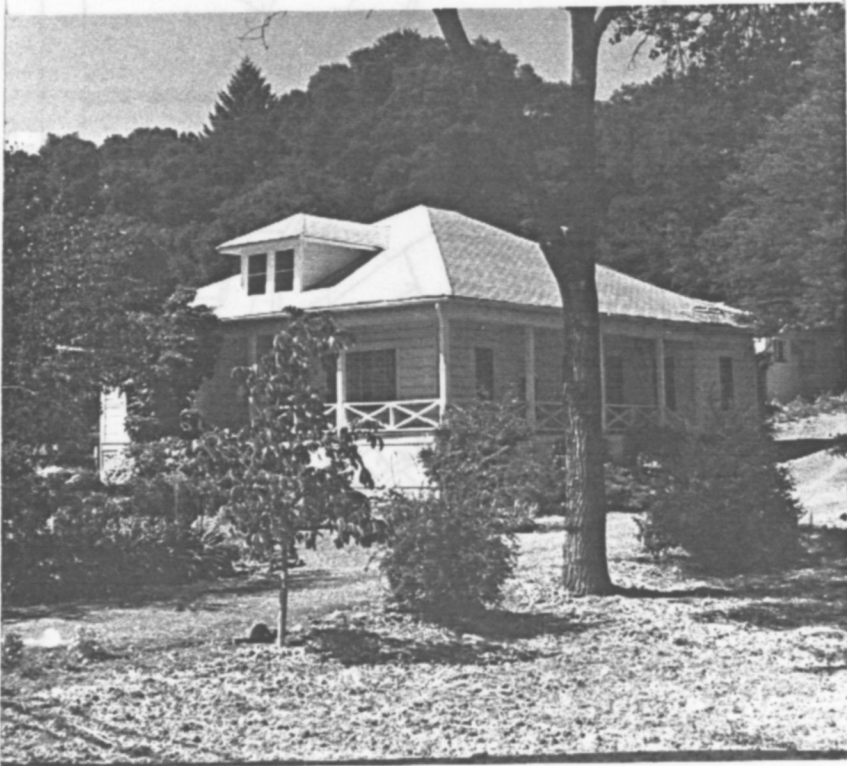
A truncated hip-roof with a hipped-roofed front dormer covers this square, one-story house. Windows are double-hung except for a large, fixed, front window. The raised foundation is covered by vertical boards while the main structure and two window dormer has channel rustic siding. A recessed porch partially extends across the front and one side, with square posts and simple, geometric balustrade. A flight of stairs on both sides lead to entrance doors.

13. Condition: Excellent ___ Good X Fair ___ Deteriorated ___ No longer in existence ___
14. Alterations: Front Window
15. Surroundings: (Check more than one if necessary) Open land ___ Scattered buildings ___ Densely built-up ___
Residential ___ Industrial ___ Commercial ___ Other: ___
16. Threats to site: None known X Private development ___ Zoning ___ Vandalism ___
Public Works project ___ Other: ___
17. Is the structure: On its original site? ___ Moved? X Unknown? ___
18. Related features: _____
