HISTORIC RESOURCES INVENTORY

- 1. Common name: ___
- 2. Historic name: _____Ellis Property
- 3. Street or rural address: 430 East Street

City Healdsburg Zip 95448 County Sonoma

- 7a. Architectural style: Queen Anne Cottage
 - 7b. Briefly describe the present *physical description* of the site or structure and describe any major alterations from its original condition:

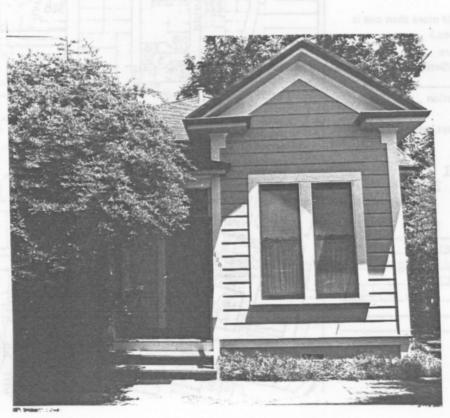
This small cottage with a combination hip and gabled roof has a plain boxed cornice with returns on the front of the gable. The double hung windows are set in pairs and singlely. The gables are open and the house is sheathed in channel rustic. There is a small porch with turned columns.

- No. 11.2				
13.	Condition: Excellent X Good Fair Deterior	ated No longer in existence			
14.	Alterations: Sun panel on roof	улотизуні завяновал вілотвін '
