HISTORIC RESOURCES INVENTORY

1. Common name: _____
2. Historic name: _____
3. Street or rural address: 429 Foss Street
City Healdsburg Ca. Zip 95448 County Sonoma
4. Parcel number: 002-173-19-3
5. Present Owner: Pimentiel, Anthony M. & Diane M. Address: 3204 Fulton Rd.
City Fulton, CA Zip 95439 Ownership is: Public _____ Private
6. Present Use: Residential Original use: Residential

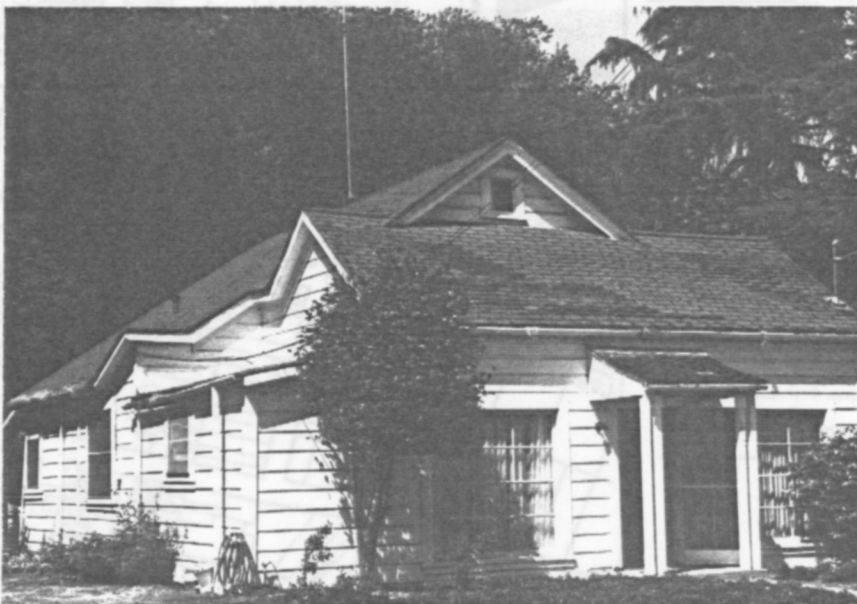
This structure is the combination of two originally separate structures. The front section is of the homestead style being a small gabled one-story structure. The front windows have been altered to two large multi-paned fixed ash. A small shed portico covers the front entry and is supported by two pairs of square posts. The larger gabled rear section has been joined at a right angle to the front. The siding is channel rustic.

13. Condition: Excellent ___ Good ___ Fair X Deteriorated ___ No longer in existence ___
14. Alterations: Rear Shed and side addition
15. Surroundings: (Check more than one if necessary) Open land ___ Scattered buildings ___ Densely built-up ___
Residential ___ Industrial ___ Commercial ___ Other: Foss Creek
16. Threats to site: None known ___ Private development ___ Zoning 022 Vandalism ___
Public Works project ___ Other: ___
17. Is the structure: On its original site? ___ Moved? X Unknown? ___
18. Related features: _____
