HISTORIC RESOURCES INVENTORY

1. Common name: _____
2. Historic name: McMinn/Whitton House
3. Street or rural address: 19185 Geyserville Avenue
City Geyserville, CA Zip 95441 County Sonoma
4. Parcel number: 140-030-17
5. Present Owner: Trentadue, Leo & Evelyn Address: 19170 Redwood Hwy.
City Geyserville, CA Zip 95441 Ownership is: Public _____ Private X
6. Present Use: Unknown Original use: Residential

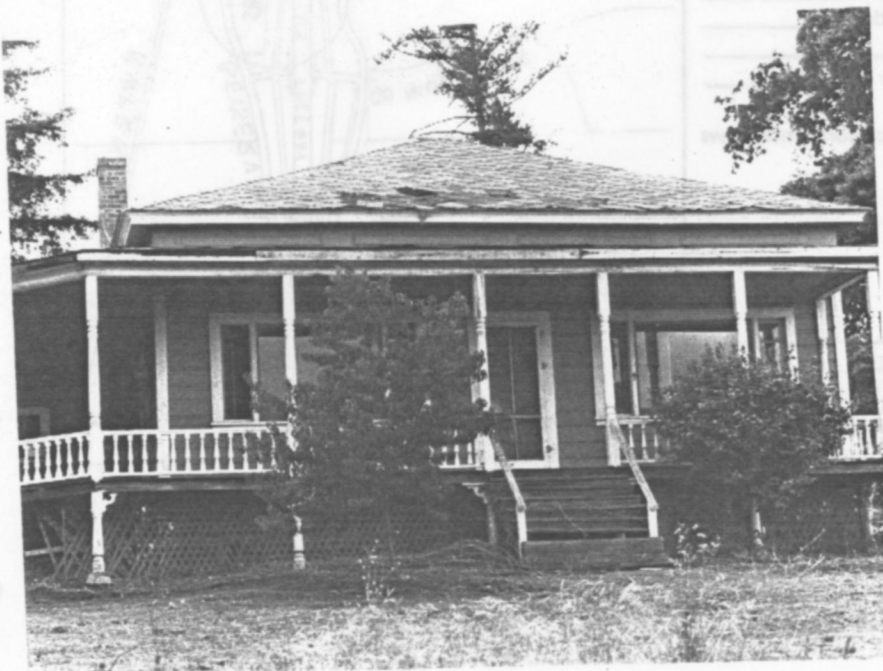
This raised, one-story house has a hip roof over a molded boxed cornice and paneled frieze. The siding is channel rustic and lattice work covers the foundation beneath the wrap-around verandah. The verandah's hip roof is supported by turned posts and its floor is supported by smaller posts with sawn brackets. The balustrade has a molded rail and turned balusters. On either side of a Craftsman style door are large picture windows flanked by small casements. Large additions are found on the side and in the rear.

13. Condition: Excellent _____ Good _____ Fair X Deteriorated _____ No longer in existence _____
14. Alterations: _____
15. Surroundings: (Check more than one if necessary) Open land X Scattered buildings _____ Densely built-up _____
Residential _____ Industrial _____ Commercial _____ Other: _____
16. Threats to site: None known X Private development _____ Zoning _____ Vandalism _____
Public Works project _____ Other: _____
17. Is the structure: On its original site? X Moved? _____ Unknown? _____
18. Related features: Detached shed, redwood, palm
