State of California – The Resources Agency DEPARTMENT OF PARKS AND RECREATION HISTORIC RESOURCES INVENTORY			Ser. No HABS HAER NR _4 SHL Loc UTM: A 10/511290/4274930 B C D			oc	
IDE	NTIF	ICATION	andScattared	if necessary) Open Ia	ack more than one	Surroundings: (Ch	,81
	1.	Common name:		The state and the state of the	industrialCo	TELEVISION N	
	2.	Historic name: Cerri He	ouse	Private development	Nora known X	Threats to site:	.01
	3.	Street or rural address:11	0 Grant Str	eet		feast service criters	
		City Healdsburg			CountyS	onoma	
	4.	Parcel number:0	02-112-27	.663.	ge Walhut c	door. Lar	.81
	5.	Present Owner: Hampton,	Kenneth R.	& Tamara M.	Address: 797	Whitegate	Ave
		CityHealdsburg	Zip	95448 Ownership	is: Public	PrivateX	17
	6.	Present Use: Commercia	1 deltetil	Original use:	Residenti	al	2.1 art

DESCRIPTION

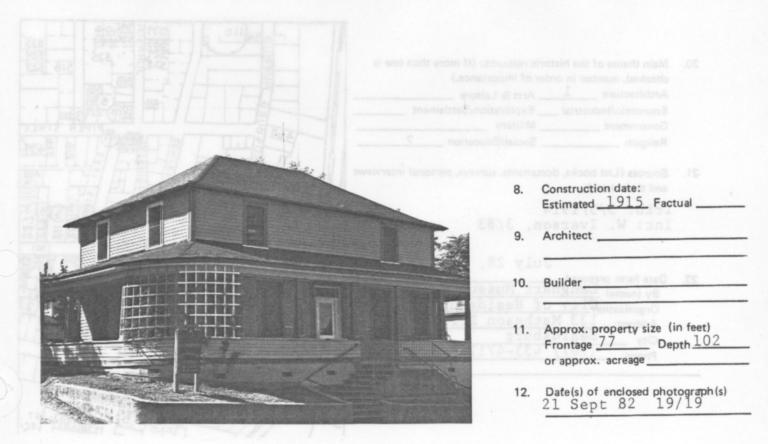
This large rectangular two-story house has a hip roof with decorative cut rafter tails. Individual double-hung windows are placed symmetrically around both floors. The expansive verandah curves around the front and side and has a solid balustrade of lap siding with tapered constructed pillars supporting the porch roof.

- 13. Condition: Excellent X Good _____ Fair ____ Deteriorated _____ No longer in existence
- 14. Alterations: New handrails on porch steps. Trim in the form of molding has been added to porch, posts, windows & doors. New skirting plywoo
