**HISTORIC RESOURCES INVENTORY**

1. Common name: \_\_\_\_\_
2. Historic name: \_\_\_\_\_
3. Street or rural address: 210 Grant Street  
City Healdsburg Zip 95448 County Sonoma
4. Parcel number: 002-123-09
5. Present Owner: Minter, Gerald L & Jacqueline M Address: 2845 Concord Lane  
City Santa Clara Zip 95051 Ownership is: Public \_\_\_\_\_ Private X
6. Present Use: Residential Original use: Residential

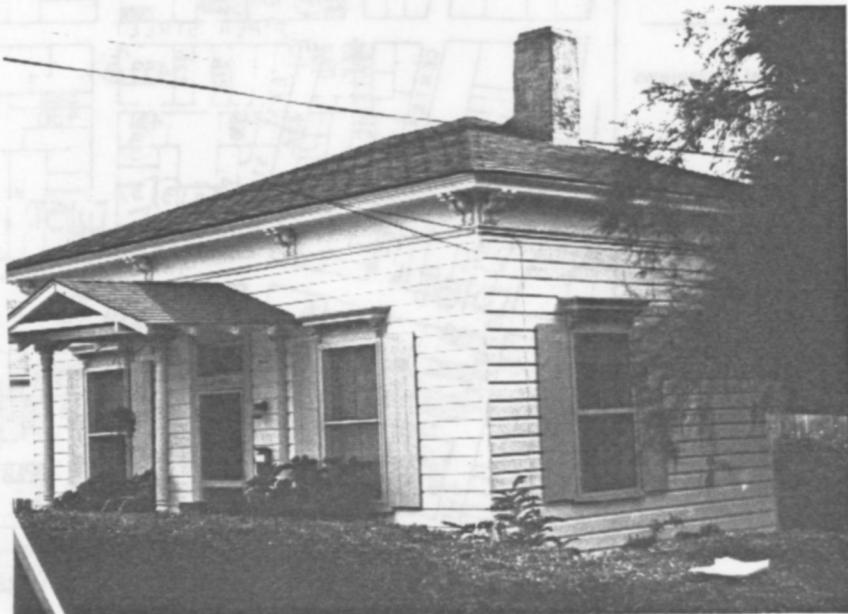
This rectilinear cottage with hip roof has a boxed cornice with paired sawn brackets over a plain frieze. Double hung windows are placed singly around the structure and are capped with small flat hoods with sawn brackets. Sill blocks appearing on similar house at 542 Johnson Street appear to have been removed. The entry portico appears to have been altered with original corinthian columns and pilasters retained but the portico roof which was probably hipped with a bracketed cornice has been changed to an open framed gable roof.
