## HISTORIC RESOURCES INVENTORY

| | Common name: | Other: | Commercial | leintsubni | Residential X. | |
|---|---|---|---|---|---|---|
| 2. | Historic name: Jane Kelle | ey House | X_Private devel-<br>Other: | None known set | Threats to site:<br>Public Works proj | 16. |
| 3. | Street or rural address: 221 Grant | Street | Carlo | On its original | tenupurus edi al | .51 |

- 7a. Architectural style: Queen Anne
- 7b. Briefly describe the present *physical description* of the site or structure and describe any major alterations from its original condition:

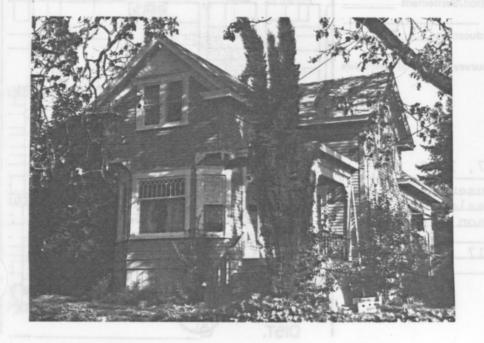
This 1½ story cottage has open gables sheathed in narrow rustic siding. The front gabled section consists of a slanted bay on the first floor becoming squared off on the second floor. Cut shingles fill in above the gable windows and the lower front window has a decorative glass pattern. The small front porch consists of turned columns with brackets supporting fretwork. Original stairs and balustrade has been replaced.
